This is an old draft of some TH400 oil pump technical information. Diagrams supplied by General Motors and ATSG have been noted and are the property of the credited entity.

SECTION A

DISASSEMBLY AND INSPECTION OF THE OIL PUMP

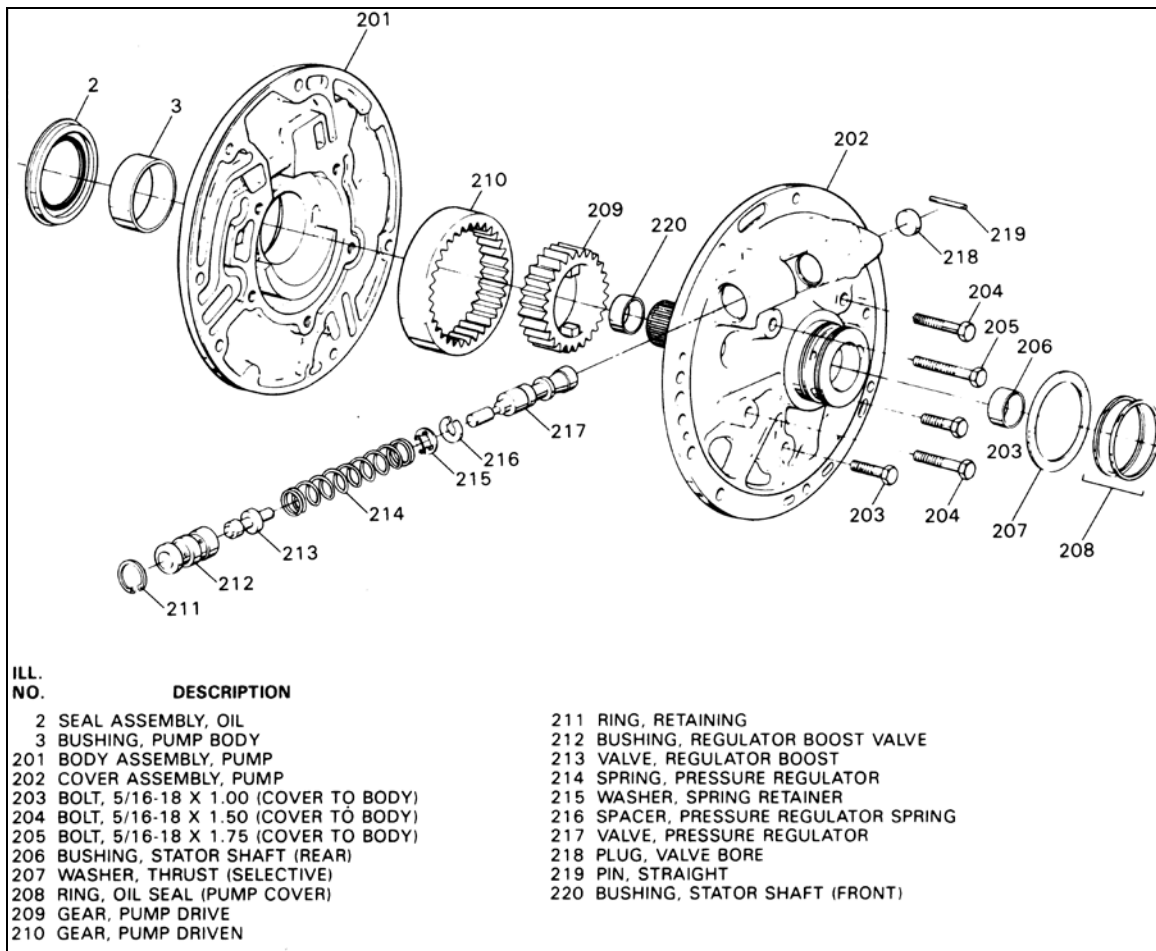
FIGURE 10A-1

Figure 10A-1 is the master schematic of the oil pump and related components.

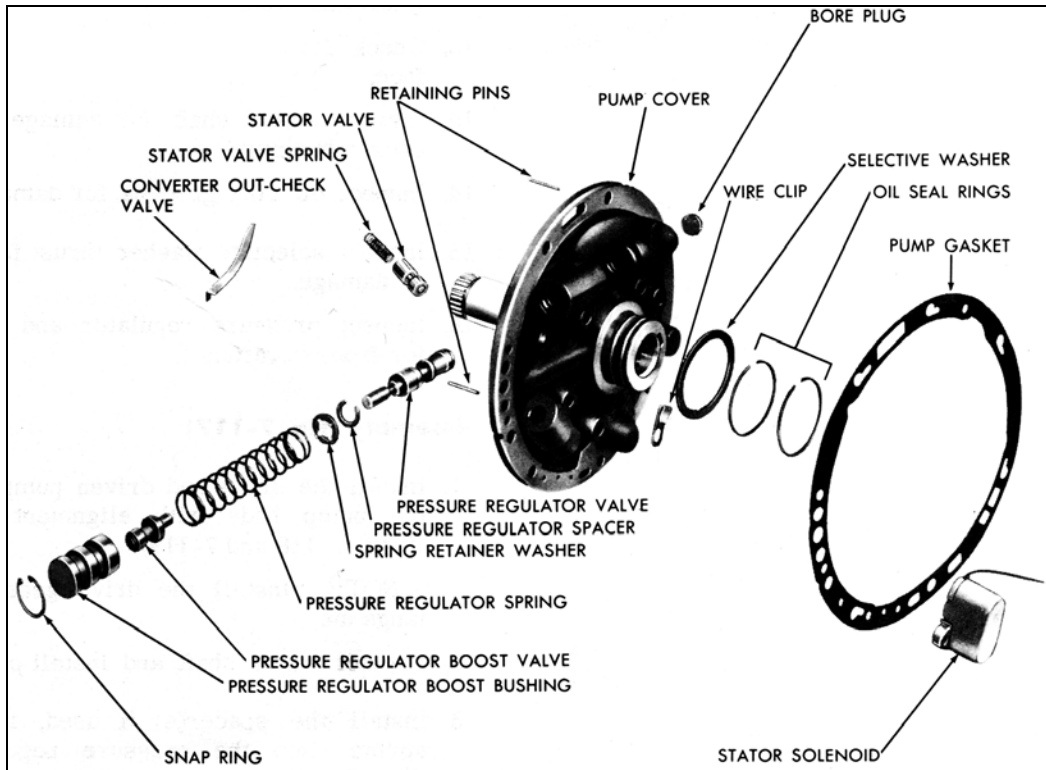
FIGURE 10A-2

Figure 10A-2 is the master schematic of the variable pitch oil pump cover and related components.

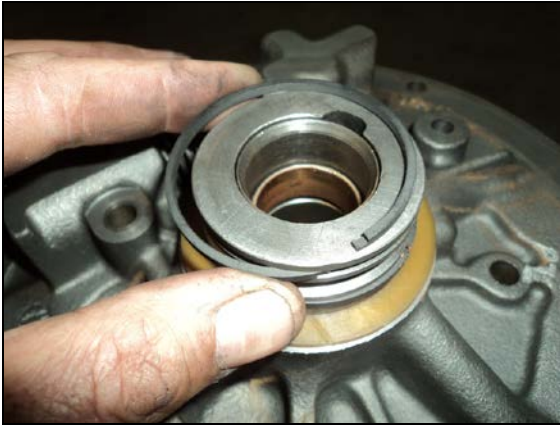
FIGURE 10A-4

Remove and discard the two oil seal rings (208) from the pump cover (202). 1964 to 1974 models were assembled with iron hook type rings. See Figure 10A-4. 1975 and up models received scarf cut Teflon type rings. Inspect the seal ring grooves for signs of wear or damage. See Figure 10A-5. Ring groove width should measure @ approximately .095". Ring groove depth should measure @ approximately .090". If the seal ring (s) is stuck or sticking in its groove, check for peening of the ring groove, and replace the pump cover if necessary.

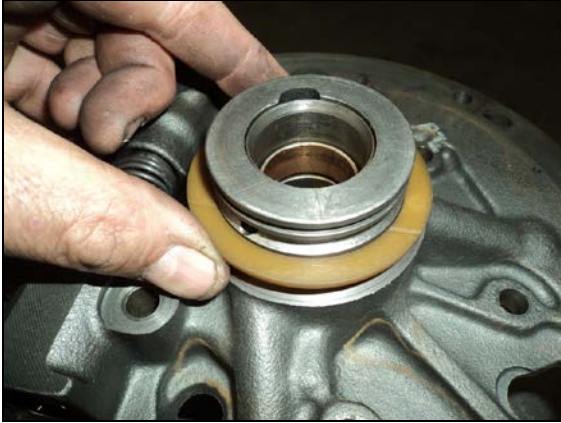
FIGURE 10A-6

Remove the selective thrust washer (207) from the rear of the pump cover. See Figure 10A-6. Inspect the washer for signs of wear or damage. Place the stator shaft down thru a hole in the workbench and remove the five pump cover to pump body bolts (203,204,205). See Figure 10A-7.

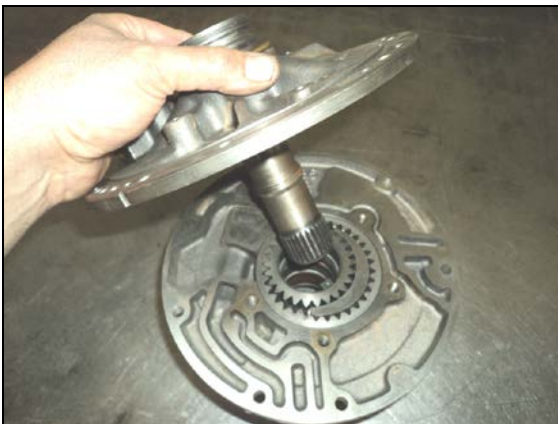
FIGURE 10A-8

Remove the pump cover from the pump body (201). See Figure 10A-8. Use Figure 10A-10 as a guide for the removal of the pressure regulator assembly (211,212,213,214,215,216,217) from its bore in the pump cover. Mount the pump cover assembly in a padded vice to support it during removal of the pressure regulator assembly. Remove the retaining ring (211), the regulator boost valve bushing (212), the regulator boost valve (213), and the pressure regulator spring (214). See Figure 10A-9.

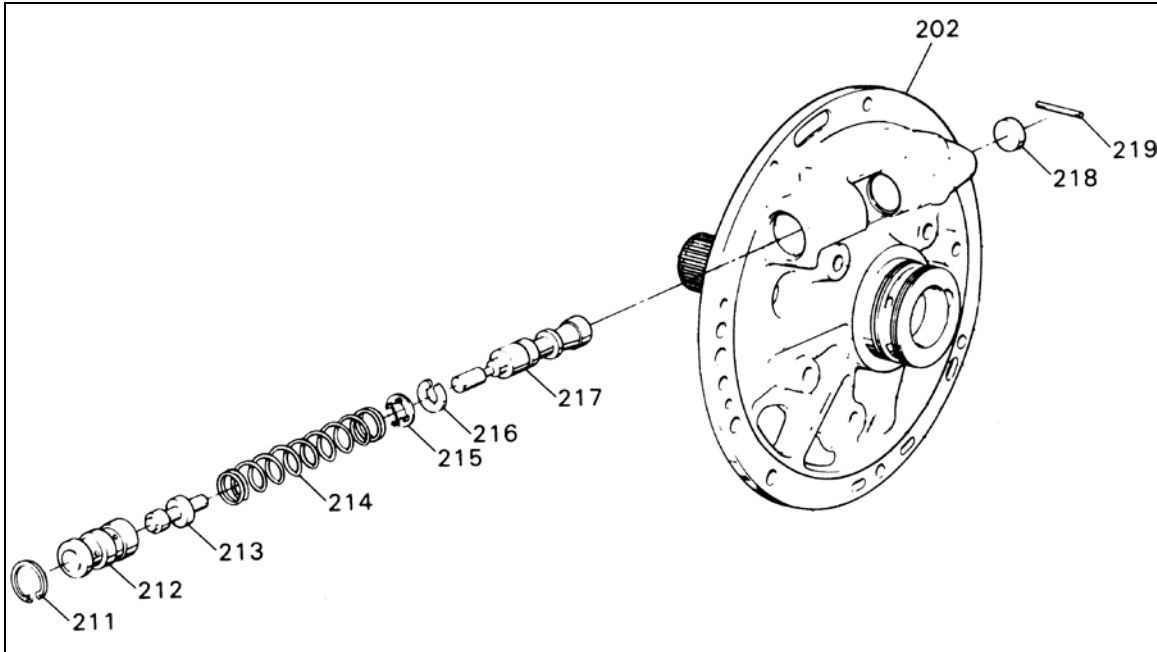
FIGURE 10A-10

CAUTION: THE PRESSURE REGULATOR SPRING IS TIGHTLY COMPRESSED AND WILL FORCE THE VALVE BUSHING OUT OF THE BORE WHEN THE SNAP RING IS REMOVED IF THE BUSHING IS NOT HELD SECURELY. DURING REMOVAL, KEEP PRESSURE ON THE ASSEMBLY AND RELEASE IT SLOWLY OUT OF THE BORE.

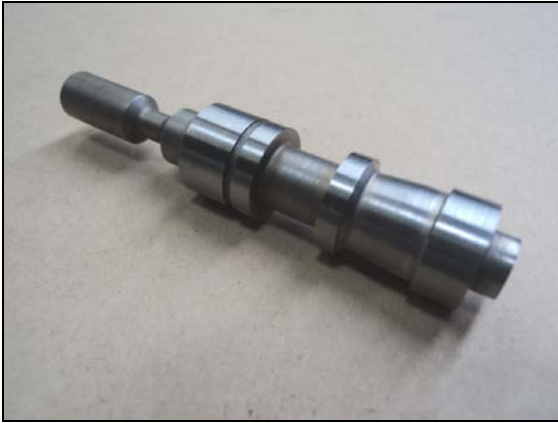
FIGURE 10A-13

Inspect the lands of the pressure regulator valve for signs of scoring or wear. See Figure 10A-13. Scoring may be a sign of excessive bore wear in the pump cover. This will be checked shortly. Prepare the pressure regulator valve by chucking up the outboard end of the valve in a cordless drill. See Figure 10A-14. The outboard end of the valve does not operate in the valve bore and will not become damaged by chucking it up in the drill. Lubricate the valve with penetrating oil, and polish the valve lands for 5 to 10 seconds with a fine scotch pad. Wash the valve with clean solvent and blow it dry with compressed air. The four lands on the pressure regulator valve should measure in @ .624" + or - .0005". See Figure 10A-15. Note that there are first design and second design pressure regulator valves. Identify the type of pressure regulator valve in use. The first design valve contains oil holes, an orifice cup plug, and has no stem on the inboard end of the valve in comparison with the second design "solid" valve. See Figure 10A-16. Do not interchange pressure regulator valves without reviewing the information on Page ###.

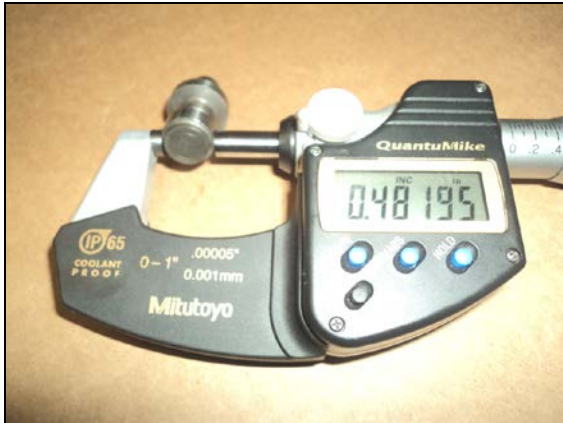
FIGURE 10A-17

Inspect and prepare the regulator boost valve in the same manner as the pressure regulator valve. Inspect the bushing for signs of wear or damage. Fit the boost valve into the bushing and verify smooth in and out operation. Use a micrometer to measure the regulator boost valve lands. The small land on the boost valve should measure in @ approximately .482". The large land on the boost valve should measure in @ approximately .604". See Figures 10A-17 and 10A-18.

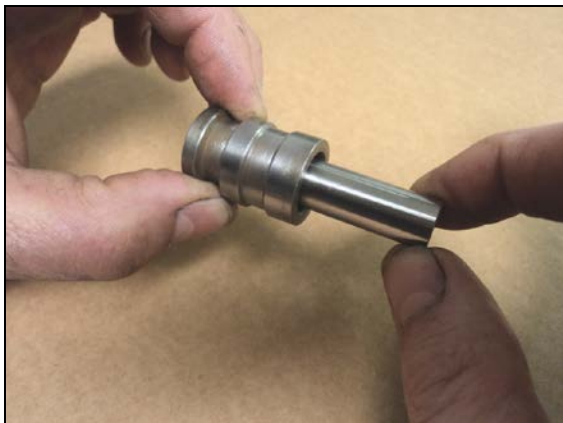
FIGURE 10A-19

Use pin gages to measure the bushing bore diameters. The small bore should measure in @ approximately .483". See Figure 10A-19. The large bore should measure in @ approximately .605". See Figure 10A-20. The recommended boost valve to bushing bore clearance is .0005" to .0012". Subtract the measured boost valve land diameter value from the measured bushing bore diameter value to arrive at the boost valve to bushing bore clearance. Note that early models bushings are aluminum, and are prone to increased wear.

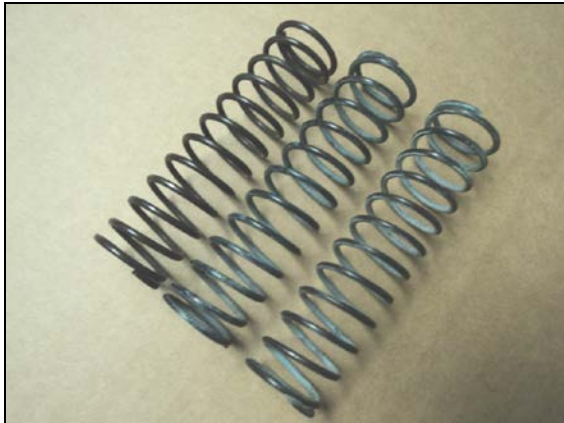
FIGURE 10A-22

Inspect the pressure regulator spring for signs of distortion and collapsed coils. There are three versions of the production pressure regulator spring. Early models were plain in color, and later models were color coded either blue or white. See Figure 10A-21. Although the springs are all slightly different in appearance, they all share the same rate at the installed height. If you have access to a spring tester you can check the rate of the pressure regulator spring. At its installed height of 1.540", all production pressure regulator springs should weigh in @ 17.5 pounds. Inspection of a production pressure regulator spring with the use of a specialty RIMAC spring tester is shown in Figure 10A-22. Rates of 18 and up pounds indicate an aftermarket pressure regulator spring has already been installed during prior service.

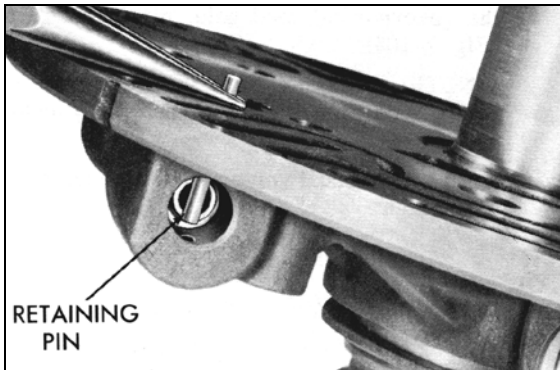
FIGURE 10A-23

With variable pitch models, remove the retaining pin, stator valve spring, and stator valve. See Figures 10A-23 and 10A-24. Inspect the spring for damage. Inspect the lands of the stator valve for signs of scoring or wear. Light scoring can be removed by lubricating the valve with penetrating oil and polishing the lands with a fine Scotch pad. Inspect the bore for signs of wear or damage.

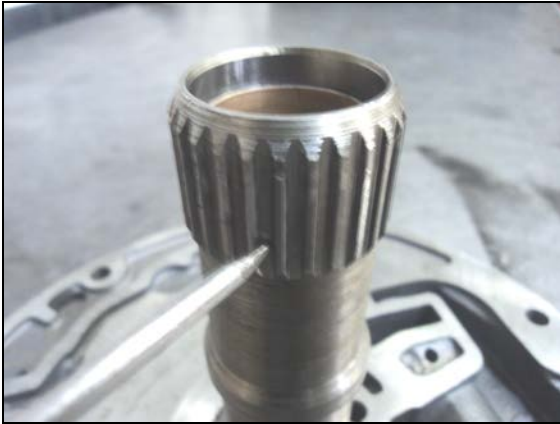
FIGURE 10A-25

Inspect the splines of the stator shaft for signs of wear or damage. The splines should be square along their full length and free from scoring and galling. See Figure 10A-25. Note that early models were not produced with induction hardened splines and are prone to wear. Later models were produced with induction hardened splines, eliminating wear, and are easily identified by being black in color. If replacement is necessary, aftermarket stator shafts are available. Carefully inspect the pump cover face for any signs of damage or scoring. See Figure 10A-26.

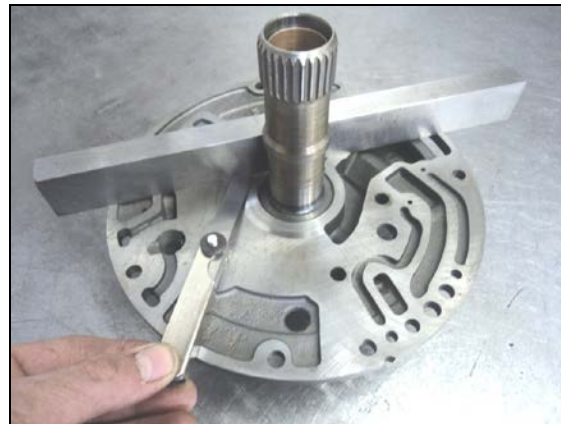
FIGURE 10A-28

Use a whetstone and clean solvent to remove any burrs and create a flat, conditioned sealing surface. Generate a nice cross hatch pattern over the entire face of the pump cover. See Figure 10A-27. Place a precision straight edge across the machined face of the pump cover. Try to install a .001" feeler gage between the straight edge and the face to verify flatness. See Figure 10A-28. The feeler gage should not fit. If the gage fits, the face is warped. This requires resurfacing or replacement of the pump cover to maintain hydraulic integrity. Resurfacing is shown on PAGE####. If you will be replacing the pump body, be sure to check interchange information found on PAGE ###.

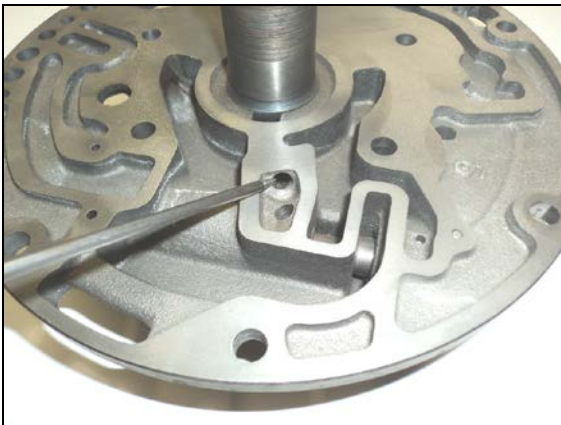
FIGURE 10A-31

Locate the converter charge passage in the pump cover. See Figure 10A-31. Using a 5/16-18 tap, thread the passage to a depth of approximately .250". See Figure 10A-32. Source a 5/16-18 X 3/16 brass set screw. See Figure 10A-33. Install the set screw into the tapped hole. Be sure the set screw is installed to a depth below the pump cover face. Drill a new converter charge orifice thru the set screw. See Figure 10A-34. With production pressure regulator springs, drill orifice from .140" to .157". With aftermarket pressure regulator springs, drill the orifice from .120" to .125".

Because most TH400 transmissions are used in high load applications, modifying the pressure regulation system for increased or fixed line pressure is common practice for increasing the torque capacity of the transmission. Because torque converter charge pressure is a derivative of line pressure, increases in line pressure result in increased converter charge pressure. If left as is, this increase in charge pressure acting on the inside of the torque converter can push the torque converter and flexplate forward into the engines crankshaft with enough force to quickly destroy the crankshaft's main thrust bearing. Placing a restriction in the converter charge circuit eliminates the chances of this occurrence. The following modification should be performed on all TH400 transmissions with increased or fixed line pressure to reduce converter charge pressure to a safe level.

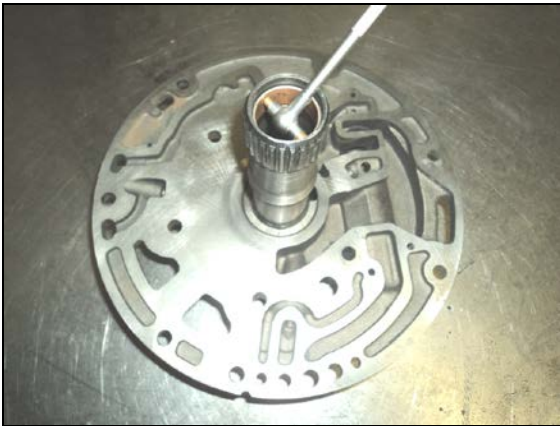
FIGURE 10A-35

With variable pitch models, be sure to check the turbine shaft sealing ring bore for wear or damage. It is located in the rear of the pump cover. See Figure 10A-35. Inspect the front (220) and rear (206) stator shaft bushings for sign of wear, scoring, pitting, or damage. Determine the stator shaft bushing to turbine shaft clearance. Carefully set a bore gage to the inside diameter of each bushing. See Figures 10A-36 and 10A-37. Use a micrometer to measure the gage. See Figure 10A-38. The bushing inside diameters should measure in @ .9990” to 1.0015”. If the bushings are not within specifications, replace them.

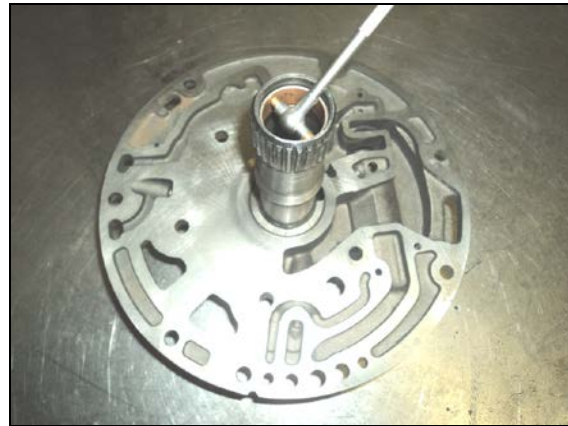
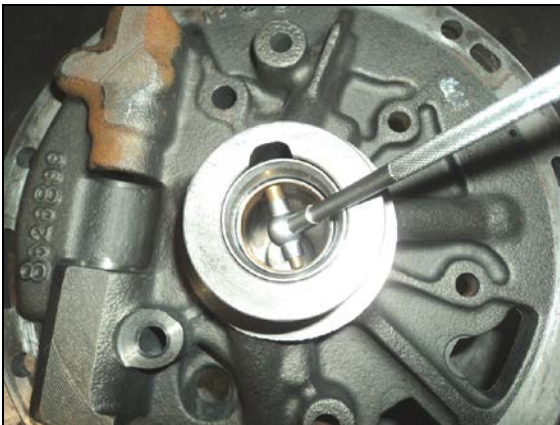
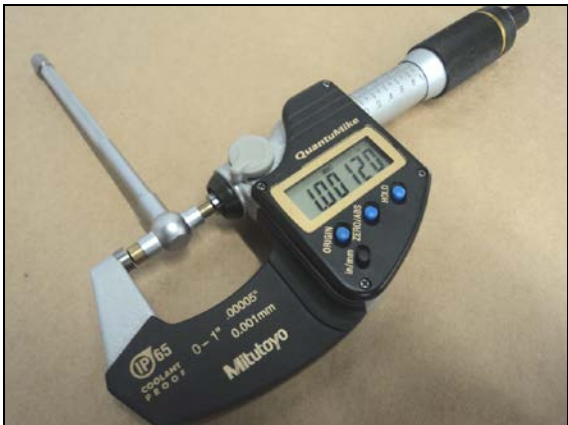
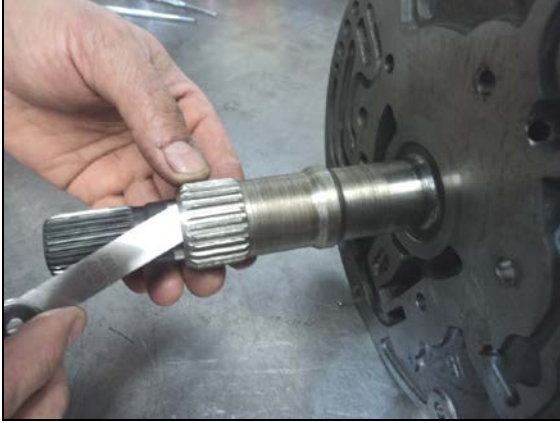
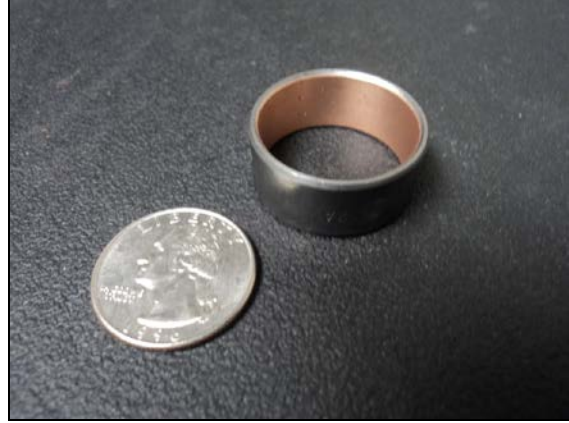
In the absence of specialized measuring tools, another method can be used to determine stator shaft bushing to turbine shaft clearance. Install the turbine shaft (601) into the pump cover. Install the correct feeler gage that just fits in between the bushing and the shaft to obtain the clearance. See Figure 10A-39. The recommended clearance is .0005” to .0035”. If the clearance is not within specifications, replace the bushing(s). Both bushings are the same. Replacement bushing is shown in Figure 10A-40. Before removing stator bushings with variable pitch models, note/record the installed depth of the bushings as an assembly aid.

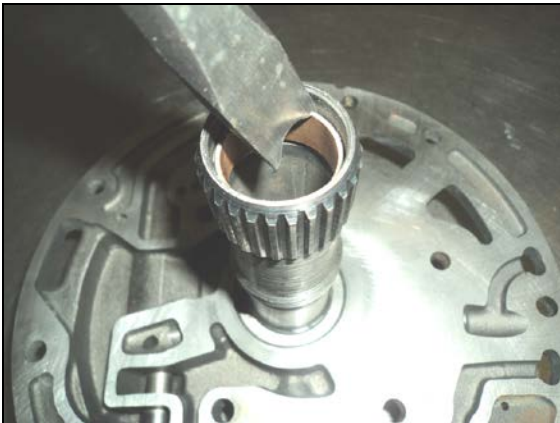
FIGURE 10A-41

Carefully cut the bushings from the stator shaft. See Figures 10A-41 and 10A-42. Use an arbor press and bushing driver to install the bushings. See Figure 10A-43. Install the front bushing to a depth of .250" below flush, and the rear bushing to a depth of .575" below flush. To verify the bushings have been installed properly, lube the bushings and install the turbine shaft (601) into the pump cover and verify smooth rotation. See Figure 10A-44.

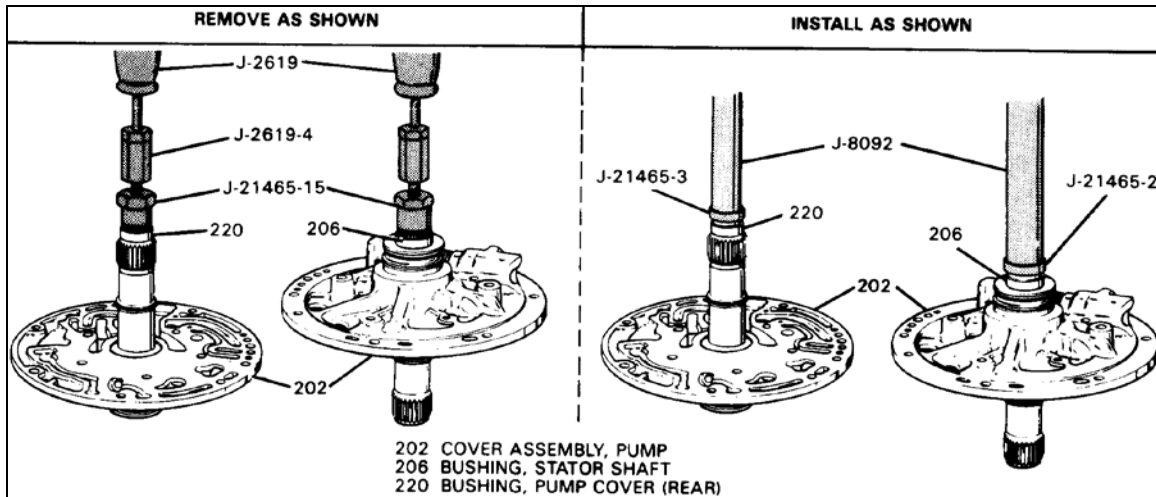
FIGURE 10A-45

The service manual procedure for bushing replacement is shown in Figure 10A-45.

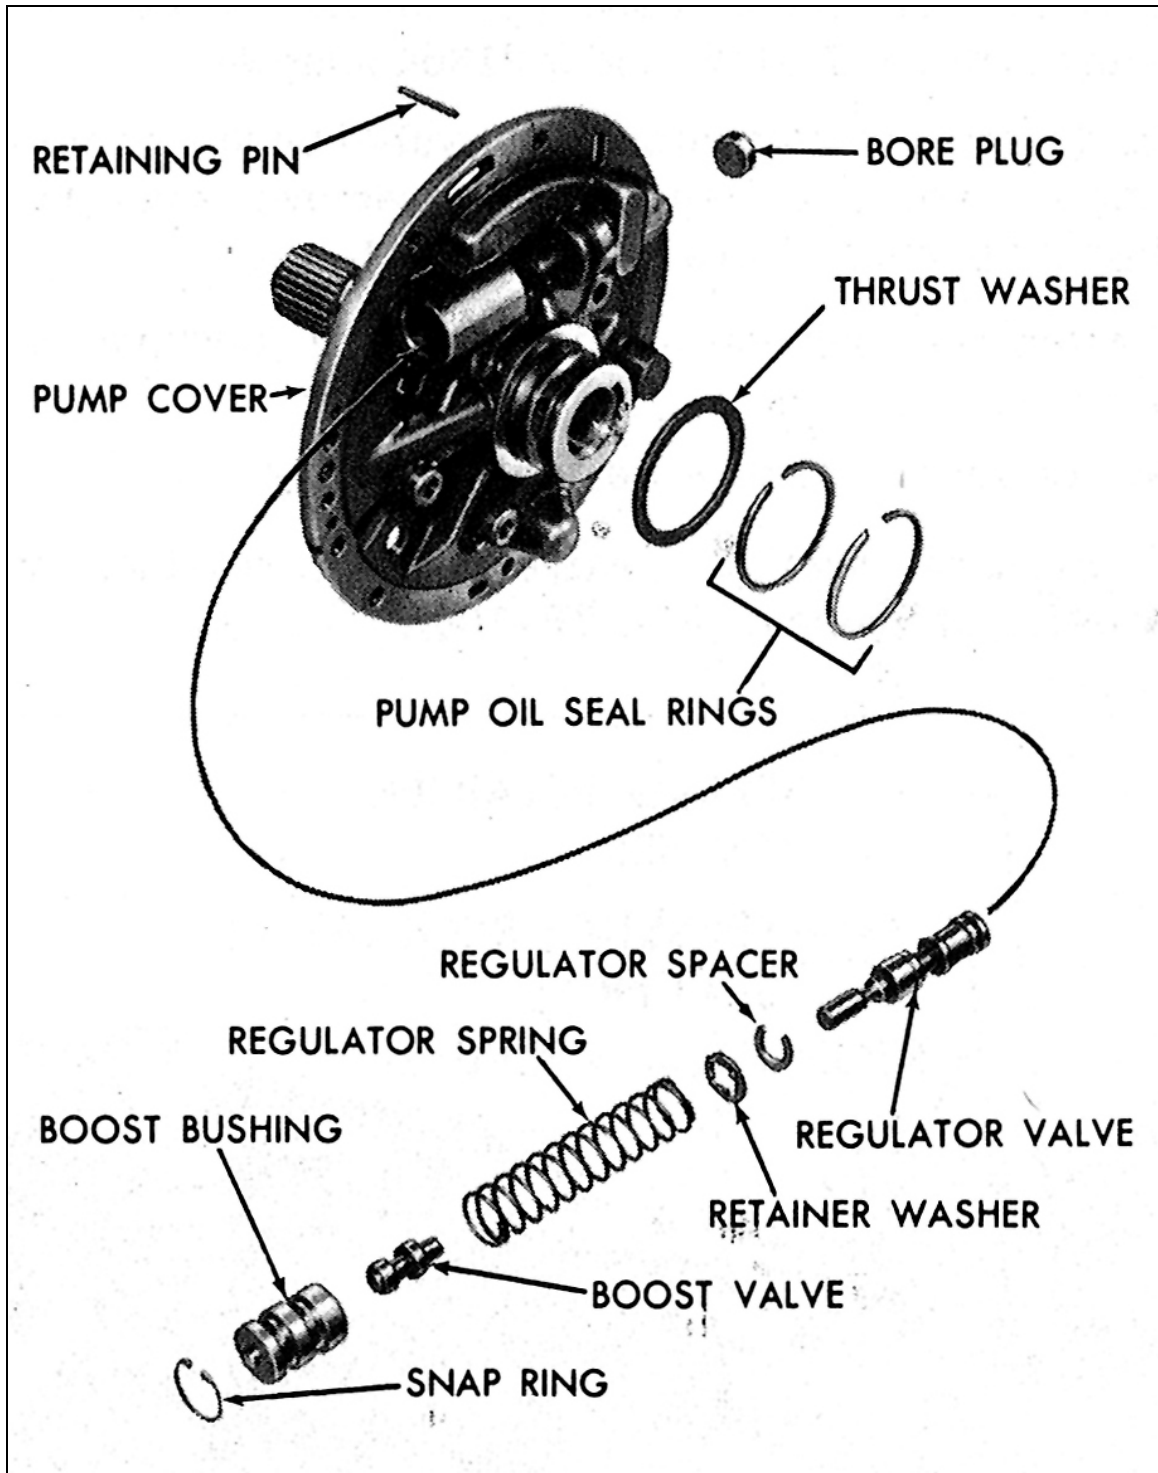
FIGURE 10A-46

Use Figure 10A-46 as a guide to install the pressure regulator assembly into its bore in the pump cover.

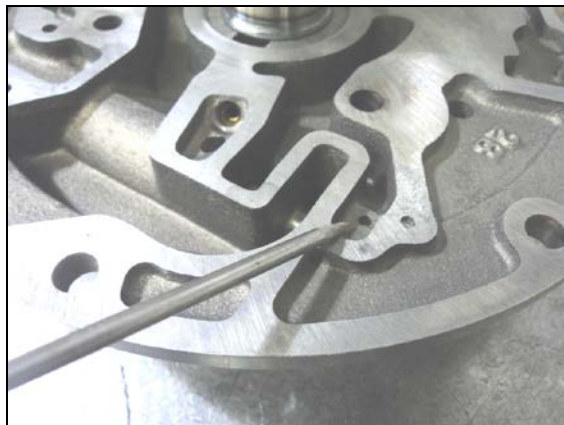
FIGURE 10A-50

Install the valve bore plug (218) and straight pin (219) into the pump cover. See Figure 10A-47. Lubricate and install the pressure regulator valve (217) into the pump cover (202). Install the pressure regulator spring spacer or spacers (216) and pressure regulator spring retainer washer (215) over the pressure regulator valve. See Figure 10A-48. Install the pressure regulator spring (214) into the bore and into engagement with the tabs on the retainer washer. Install the pressure regulator boost valve (213), stem end out, into the pressure regulator boost valve bushing (212). Keep them together with assembly lube. Install the assembly into the bore while at the same time compressing the spring enough so that the retaining ring (211) will enter its groove at the end of the bore. See Figure 10A-49. On models with the late pressure regulator valve, stroking of the pressure regulator valve can be checked by applying compressed air to the balance hole as shown in Figure 10A-50.

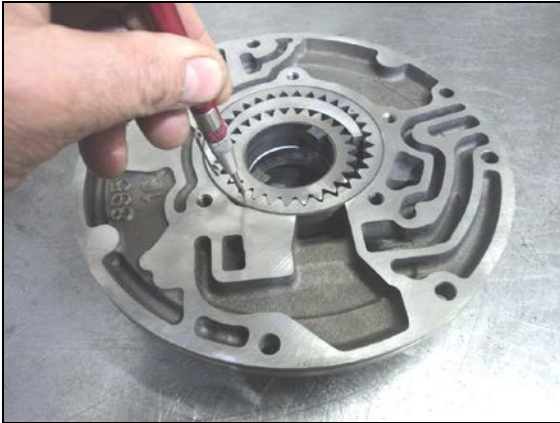
FIGURE 10A-55

Disassembly of pump gears. Before removal, use a center punch or scribe to make an identification mark on the front face of both the drive (209) and driven gears (210) for proper orientation during reassembly. See Figure 10A-55. Remove the pump drive and driven gears from the pump body (201). See Figure 10A-56. Inspect the outside diameter, faces and gear teeth of both the drive and driven gears for signs of scoring, wear, or damage. See Figure 10A-57. Inspect the drive gear drive tangs and inside diameter of the drive gear for signs of scoring, wear or damage. See Figure 10A-58. Improper torque converter to flexplate clearance will usually result in damage to the driven gear at the interface between the drive tangs and the torque converter pump drive hub.

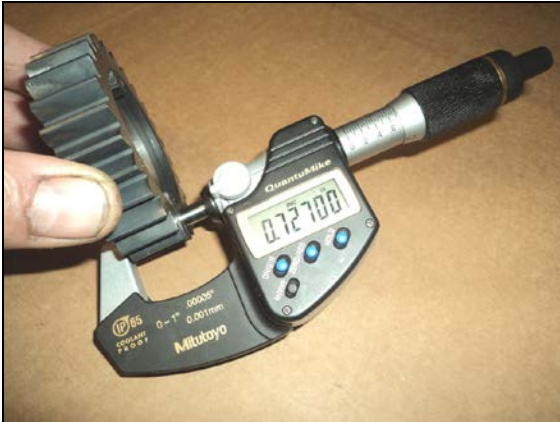
FIGURE 10A-59

Prepare the faces of both gears with a whetstone and clean solvent. Using a micrometer, measure and record the pump drive and driven gear thickness. See Figures 10A-59 and 10A-60. There is no published specification for the overall height of the gears; however production pump gears should measure in @ .7265" to .7275". If the gears come up undersize, replacement will depend on the value obtained when measuring the pump body face to gear face clearance. Note that 1964 to 1966 fixed pitch model transmissions with a casting number of 1358649 use .625" thick gears.

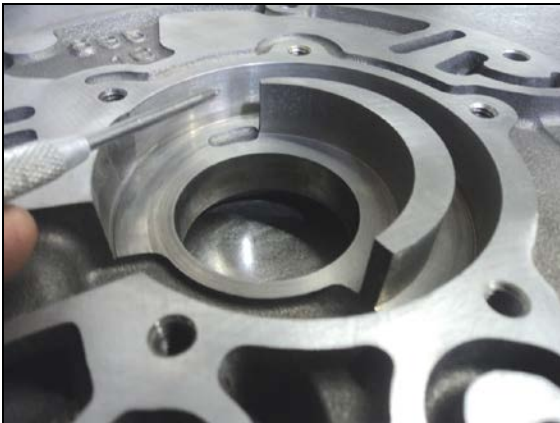
FIGURE 10A-61

Inspect the pump gear pocket. Careful inspection of this area should not be overlooked. Failure to identify wear will result in reduced oil pump efficiency. Inspect the side wall of the gear pocket for any signs of scoring or abnormal wear. See Figure 10A-61. If any wear can be felt with your fingernail, the body should be replaced. Note that there is a tight tolerance between the outer diameter of the driven gear and the side wall of the gear pocket. The side wall acts as a bearing journal that supports the driven gear outside diameter on a fluid film during operation. Inspect the pump gear pocket face for any signs of scoring or abnormal wear. See Figure 10A-62. If any wear can be felt with your fingernail, the body should be replaced.

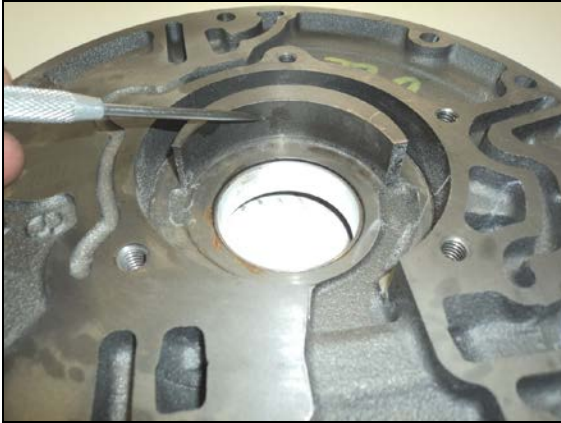
FIGURE 10A-63

Inspect the inside diameter of the crescent for any signs of scoring or abnormal wear. See Figure 10A-63. If any wear can be felt with your fingernail, the body should be replaced. Inspect the outside diameter of the crescent for any signs of scoring or abnormal wear. See Figure 10A-64. If any wear can be felt with your fingernail, the body should be replaced.

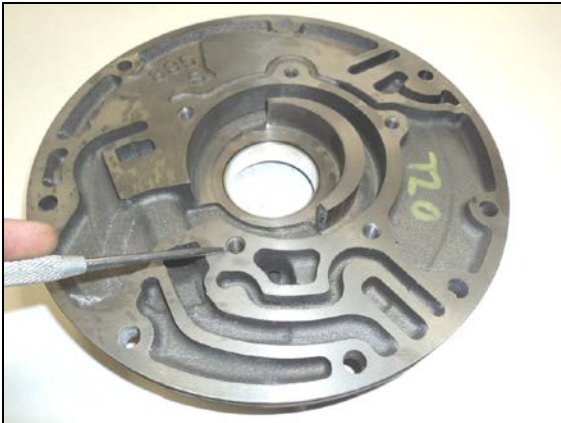
FIGURE 10A-65

Inspect the five pump body threaded bolt holes for stripped or damaged threads and repair if necessary. See Figure 10A-65. Carefully inspect the pump body face for any signs of damage or nicks that can result in hydraulic cross leaks between oil passages. See Figure 10A-66.

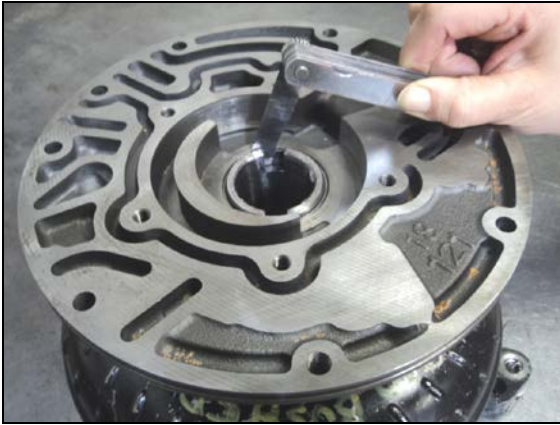
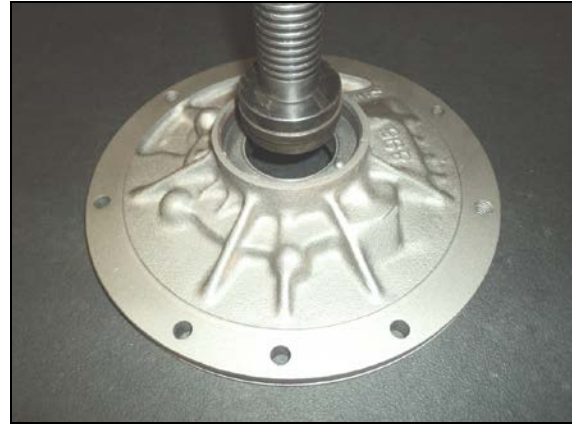
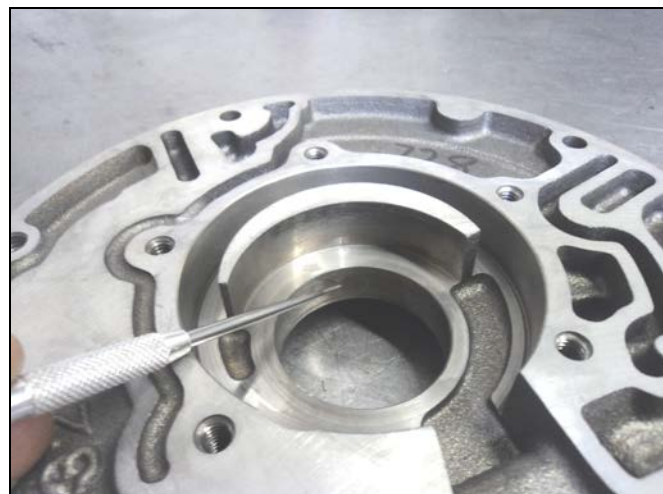
It is recommended to replace the pump body bushing (3) during the initial overhaul, and then perform inspection during future service. Install the pump body (201) over the torque converter pump drive hub. Install the correct feeler gage that just fits in between the bushing and the hub to obtain the clearance. See Figure 10A-67. The recommended clearance is .001" to .004". If the clearance is not within specifications, replace the bushing. It is recommended to remove the bushing with the appropriate bushing driver. Always begin removal of the bushing at the seal end of the pump body, working towards the pump gear pocket. See Figure 10A-68. If you start removal at the pump gear pocket you will raise burrs that will create problems during assembly. Figure 10A-69 shows the pump body bushing and the pump body. Inspect the pump body bushing bore for any abnormal wear or evidence that the bushing may have spun out in the bore. See Figure 10A-70. If during removal, the bushing was loose in the bore, or the body shows signs of bushing spin out, the body must be replaced.

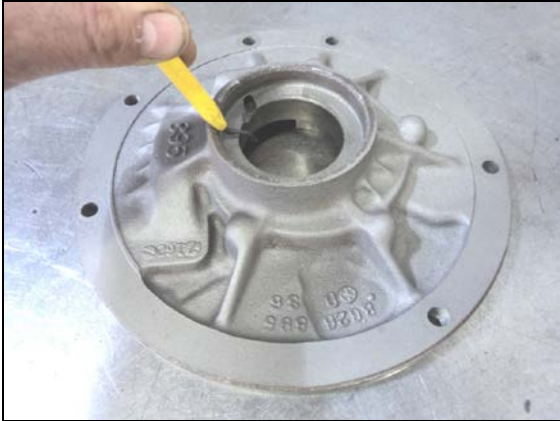
FIGURE 10A-71

Inspect the bushing bore for the presence of burrs raised during bushing removal. If any burrs are present, remove them with a small file. Using a deburring tool, gently chamfer the front and rear entrances to the pump bushing bore. See Figures 10A-71 and 10A-72.

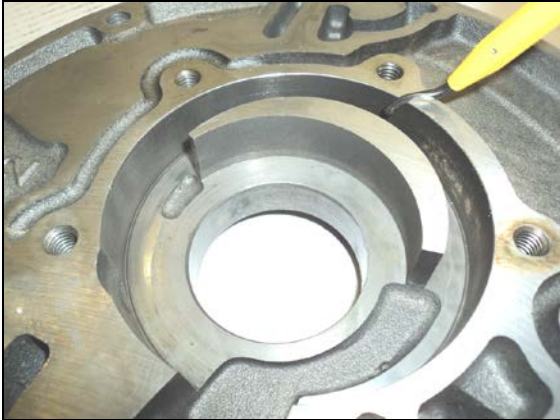
FIGURE 10A-73

Using a deburring tool, gently chamfer the front entrance to the driven gear pocket. See Figure 10A-73. Use a whetstone and clean solvent to remove any burrs and create a flat, conditioned sealing surface. See Figure 10A-74. Generate a nice cross hatch pattern over the entire face of the pump body.

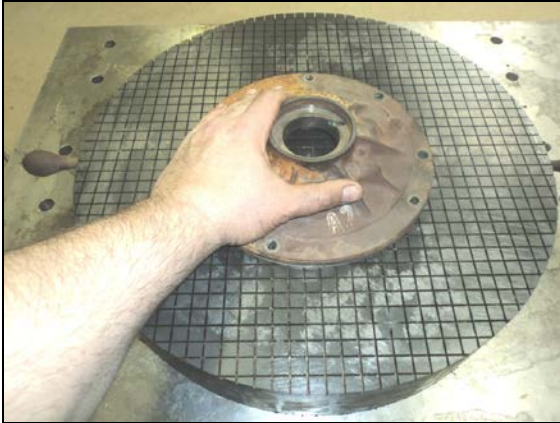
FIGURE 10A-75

Place a precision straight edge across the machined face of the pump body. Try to install a .001" feeler gage between the straight edge and the face to verify flatness. See Figure 10A-76. The feeler gage should not fit. If the gage fits, the face is warped. This requires resurfacing or replacement of the pump body to maintain hydraulic integrity. Resurfacing is shown on PAGE###. If you will be replacing the pump body, be sure to check interchange information found on PAGE ###.

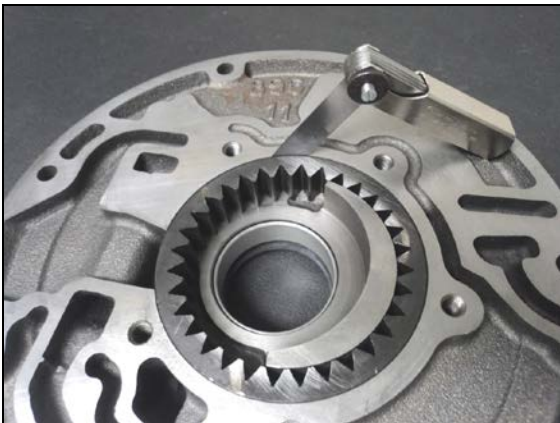
FIGURE 10A-77

Install the pump drive gear into the pump body. Install the correct feeler gage that just fits in between the outside diameter of the gear and the side wall of the gear pocket to obtain the clearance. See Figure 10A-77. The recommended clearance is .002" to .006". Note that clearance should be checked even with new aftermarket gearsets, as most have been found to spec out @ .008" to .014". Install the pump driven gear into the pump body. Install the correct feeler gage that just fits in between the inside diameter of the gear and the inside wall of the crescent to obtain the clearance. See Figure 10A-78. The recommended clearance is .002" to .0075".

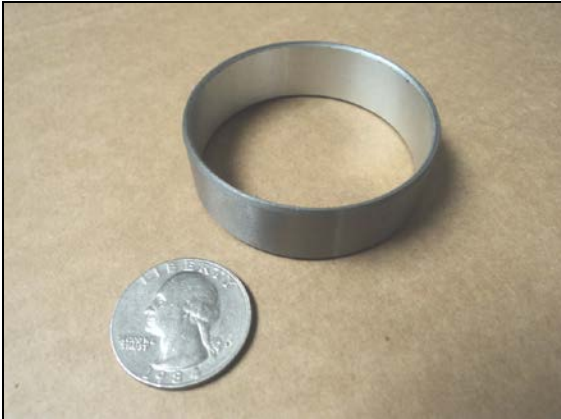
FIGURE 10A-79

Install the pump body bushing into the pump body. The replacement bushing is shown in Figure 10A-79. Note that this bushing does not like to be installed with a hammer and bushing driver. The use of an arbor press is recommended. Working from the seal end of the pump body, install the bushing flush with the top of its bore. See Figure 10A-80. To guarantee the bushing comes to a stop at the top of its bore the use of a bushing installer with an outside diameter larger than the bushing may be used.

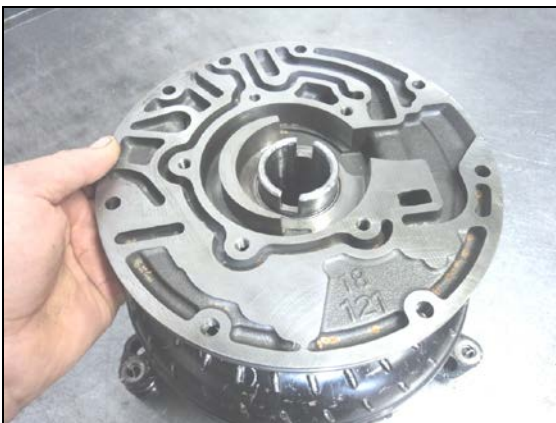
FIGURE 10A-81

To verify the bushing has been installed properly, lube the bushing and install the pump body over the torque converter pump drive hub and verify smooth rotation. See Figure 10A-81. Check the fit of the replacement front pump seal (2) on the torque converter pump drive hub before installing it into the pump body. Verify the presence of the garter spring behind the rear end of the seal lip of the front pump seal. Pack the rear seal lip with grease prior to installation to avoid the garter spring being ejected during seal installation. Using a suitable method, install a new front pump seal into the pump body. See Figure 10A-82.

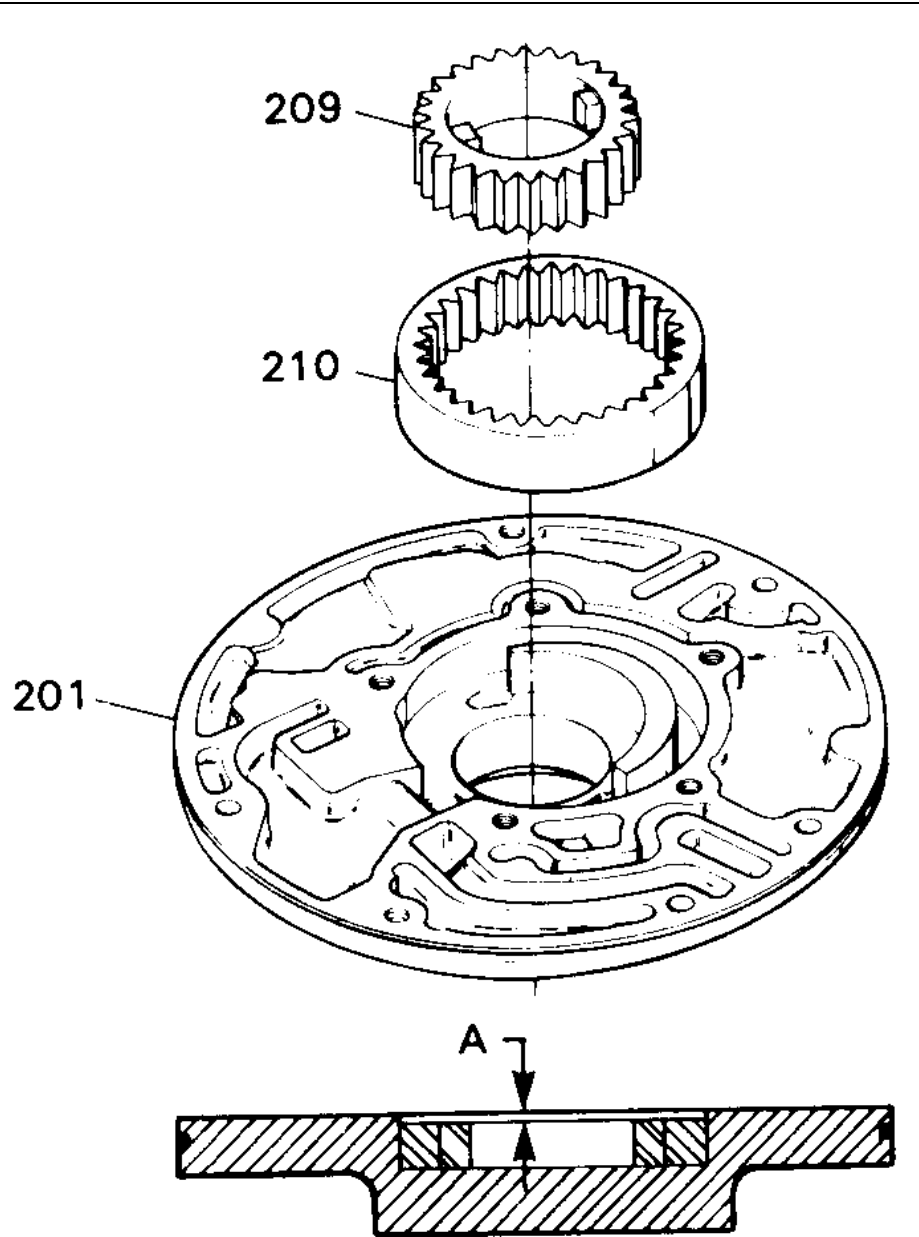
FIGURE 10A-83

Determine pump body face to gear face clearance. See Figure 10A-83.

- A .018mm - .066mm (.0007" - .0026")
- 201 BODY, PUMP
- 209 GEAR, PUMP DRIVE
- 210 GEAR, PUMP DRIVEN

Note that the published clearance values have been revised several times throughout the production of the GM TH400 transmission. Early General Motors service manuals, depending on car maker, stated either a clearance of .0007" to .0015" or .0008" to .0015". This clearance was then revised to .0008" to .0035", before the final revision recommending .0007" to .0026". From my perspective, the preferred clearance is .0007" to .0015". Extensive research has shown reduced pump pressure and volume result below 2500 RPM when the oil pump is assembled with clearances beyond .0015". Install the gears into the pump body as shown in Figure 10A-84.

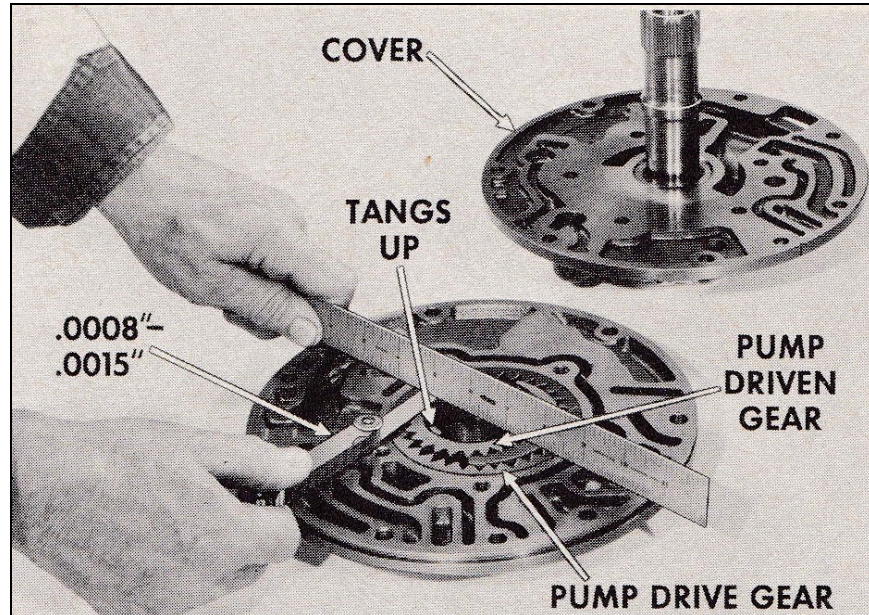
FIGURE 10A-85

Place a precision straight edge across the machined face of the pump body, extending over the pump gears. Install the correct feeler gage that just fits in between the straight edge and gear face to obtain the pump body face to gear face clearance. See Figure 10A-85.

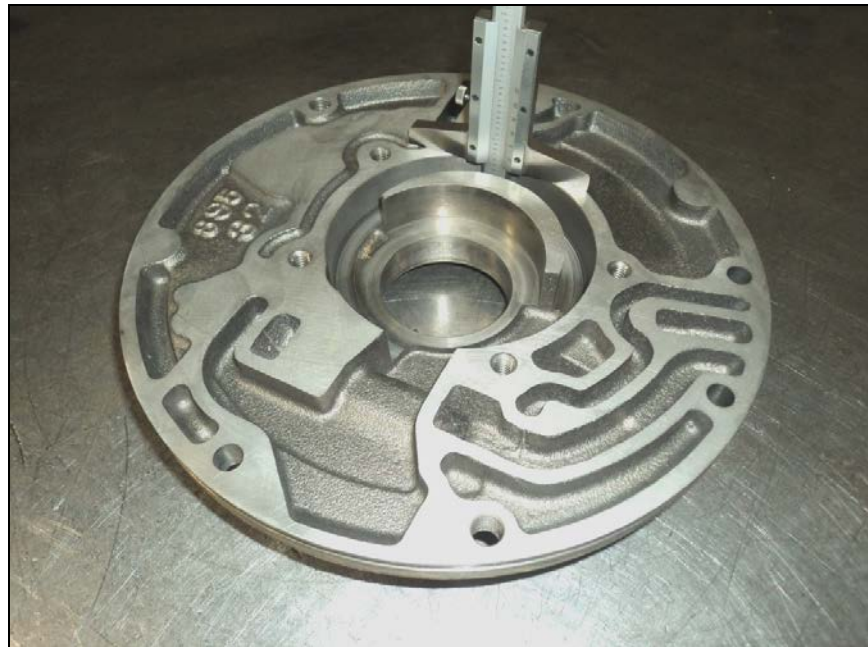
FIGURE 10A-86

Clearance may also be obtained by measuring the gear pocket depth with a depth gage and subtracting the gear thickness from it. See Figure 10A-86. If the clearance is excessive, exchange the pump body or gear set.

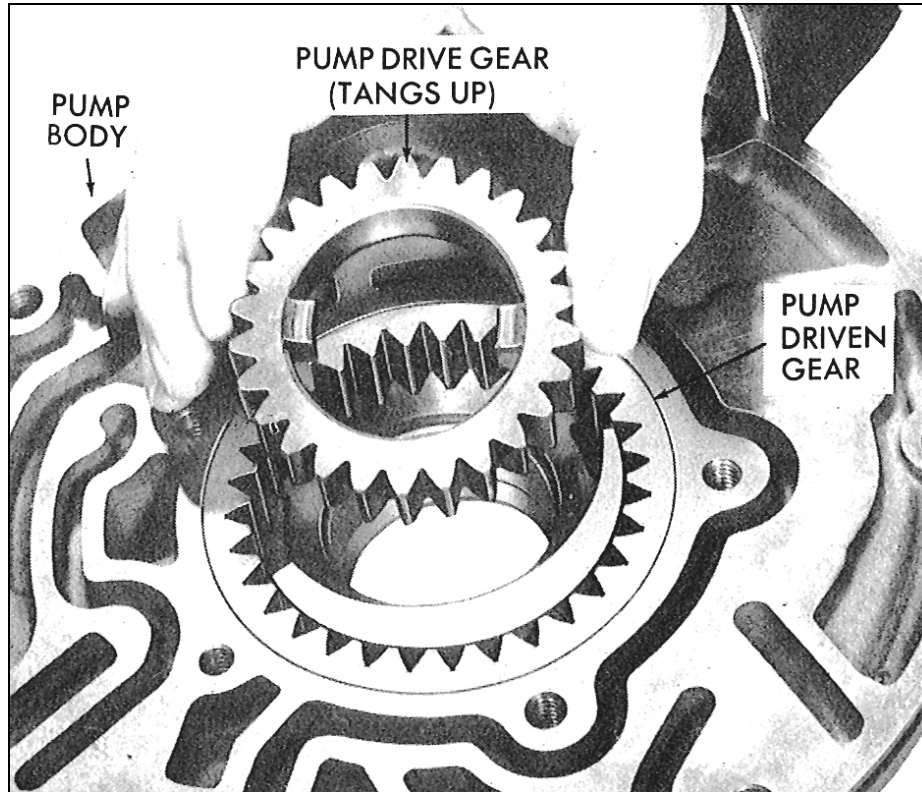
FIGURE 10A-87

Once the recommended clearance has been established, remove the pump gears from the pump body. To prevent pump damage from a dry start up, pack the pump gear pocket with assembly lube. With the identification mark facing up, reinstall the pump drive gear into the pump body. Reinstall the pump driven gear into the pump body with the drive tangs facing up. See Figure 10A-87.

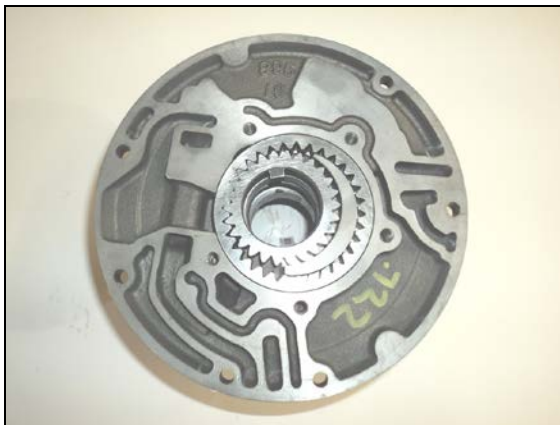
FIGURE 10A-88

Position the assembled pump body with the bushing bore over a hole in the workbench. See Figure 10A-88. Install the assembled pump cover over the pump body and align the bolt holes. See Figure 10A-89.

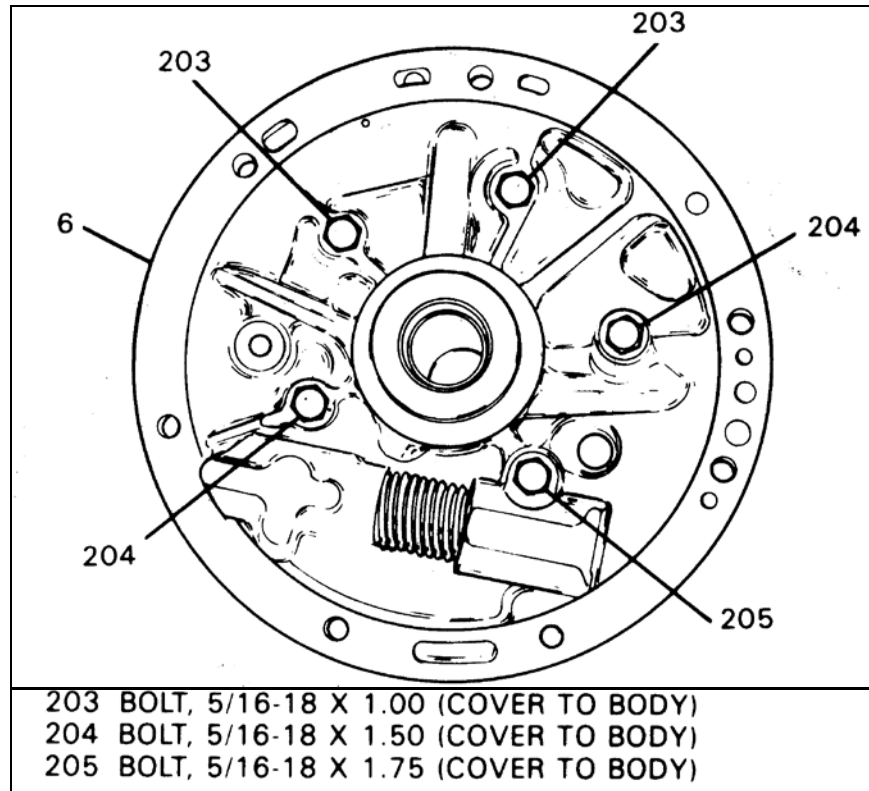
FIGURE 10A-90

Loosely install the five pump cover to pump body bolts (203,204,205). See Figure 10A-90.
