This is an old draft of some TH400 oil pump technical information. Diagrams supplied by General Motors and ATSG have been noted and are the property of the credited entity.

SECTION A

DISASSEMBLY AND INSPECTION OF THE OIL PUMP

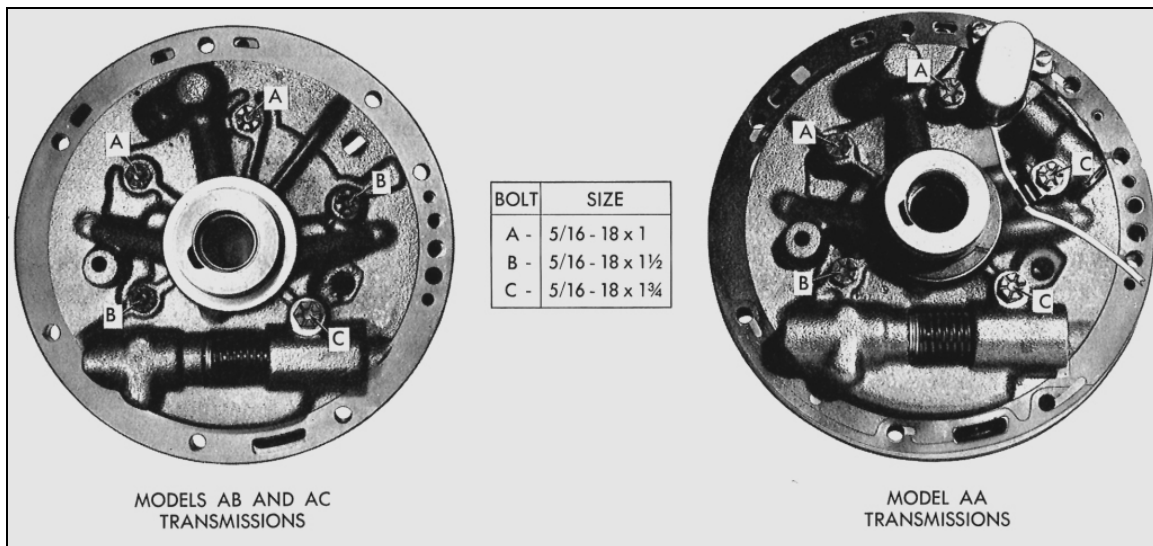
FIGURE 10A-91

On variable pitch models, the clip that retains the stator solenoid wire attaches to the “C” bolt adjacent to the stator valve. A longer bolt is used at this location. See Figure 10A-91.

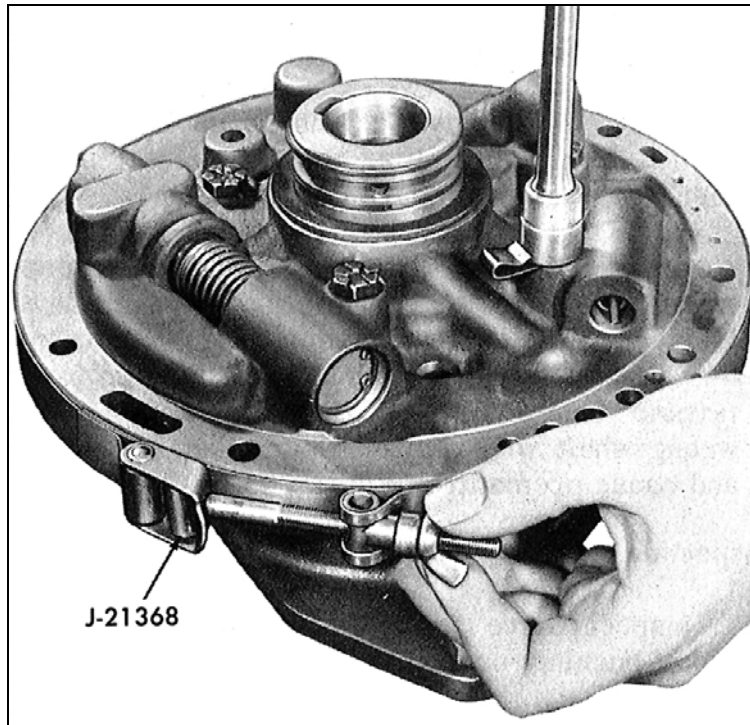
FIGURE 10A-92

To align the two pump sections, a pump alignment tool is used. Install and tighten the pump alignment tool around the outside diameter of the pump assembly. Be sure to align the thru holes in the body and cover for the pump to case bolts. This can be done with a tapered punch. The early service manual version is shown in Figure 10A-92. Note the stator solenoid wire retaining clip in the photo. A later version is shown in Figure 10A-93.

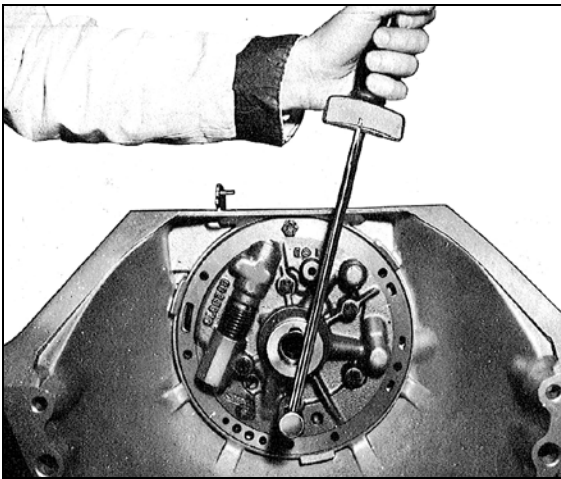
FIGURE 10A-94

In the absence of a pump alignment tool, the pump assembly may be installed upside down in its bore in the transmission case to align the two sections as shown in Figure 10A-94. Before installing the assembly into the case, be sure to remove any surface rust from the outside diameter of the assembly with a fine grit emery cloth. This will help to avoid the assembly becoming stuck in the transmission case. Torque the five pump cover to pump body bolts to 200 inch pounds. See Figure 10A-95.

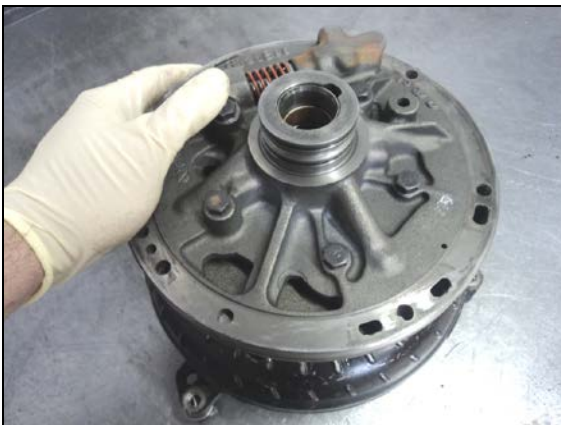
FIGURE 10A-96

Place a TH400 torque converter flat on the bench with the pump drive hub facing up and install the oil pump assembly. Verify free rotation of the pump gears. See Figure 10A-96. On variable pitch models, install and align the pump to case gasket to the rear of the pump cover. Fit the stator solenoid to the pump cover with the attaching screws. See Figure 10A-97. Torque the attaching screws to 40 to 45 inch pounds. Attach the stator solenoid wire to the clip.

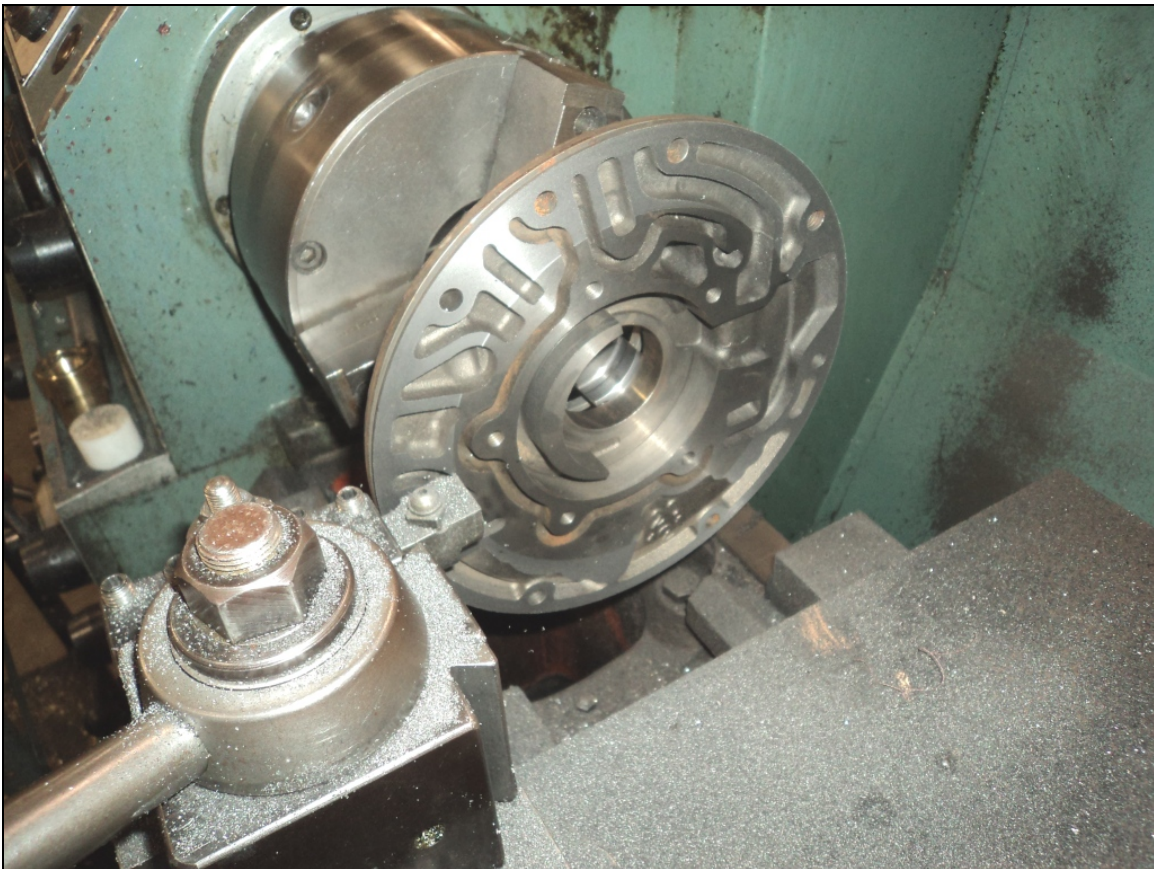
FIGURE 10B-1

Using a manual lathe, the front end of the pump body is picked up with precision soft jaws that attach to the inside diameter of the front pump bushing bore and bank against its front face. The pump body is then swept with a dial indicator to verify set up accuracy. The face of the pump body is then machined so that it is parallel and perpendicular to the bushing bore. Typically this operation will remove anywhere from .005" to .015" from the pump body face. See Figure 10B-1. Because material has been removed from the face, the pump gear pocket depth dimension will be reduced the same amount.

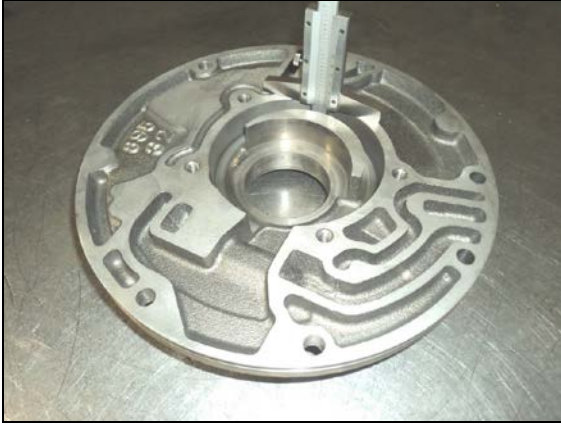
FIGURE 10B-2

This will require a set of undersize pump gears be installed to restore proper pump body face to gear face clearance. To determine the required gearset thickness, the pump gear pocket depth is measured and recorded. See Figure 10B-2. From this dimension, the recommended pump body to gear clearance of .0007" to .0015" is subtracted and you arrive at the required pump gear thickness. Undersize pump gears were produced for the TH350 transmission and are readily available. .721", .723", and .725" sets are available. If the available gear sets will not drop in, the gear set may be surface ground to the proper dimension for the application. See Figure 10B-3.

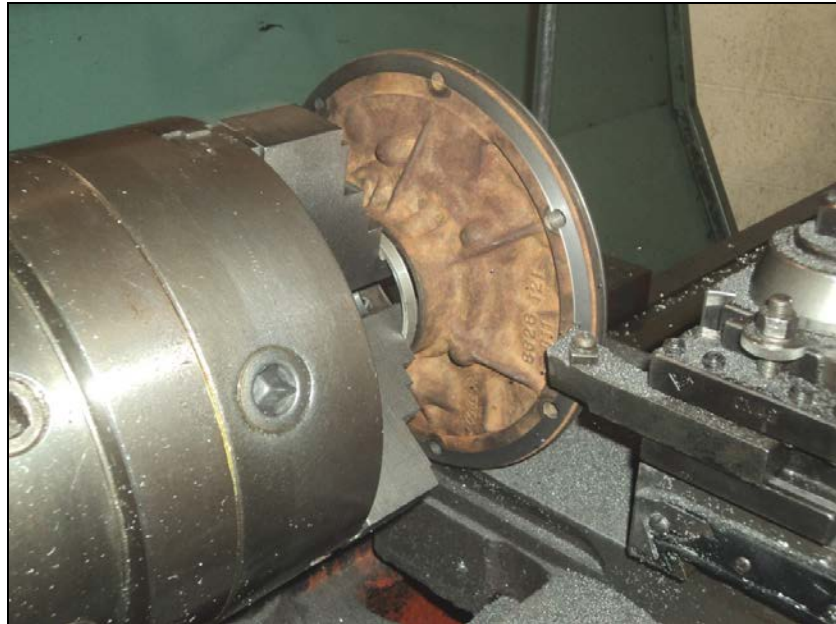
FIGURE 10B-4

If you will be installing a JW Ultra Bellhousing, perform this next operation. Without removing the pump body from the jaws, bring the facing tool to the pump to bellhousing mounting face and machine the mounting pad parallel to the pump body face. See Figure 10B-4.

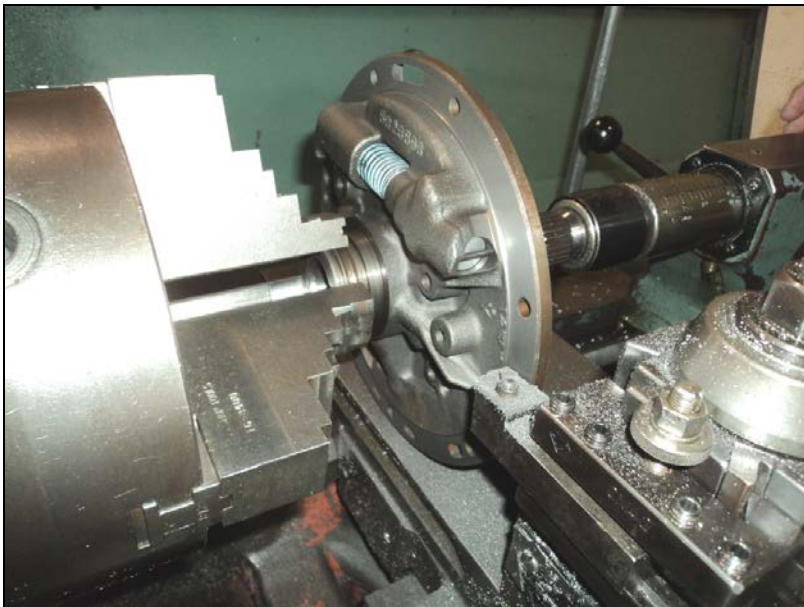
FIGURE 10B-6

Resurfacing the pump cover requires a different set up than the pump body. The rear end of the pump cover is picked up with precision soft jaws that attach to the forward clutch sealing ring boss outer diameter and bank against its face. At the front end, the front stator tube bushing is removed, and the tube is fitted with a precision plug and live center. The pump cover is then swept with a dial indicator to verify set up accuracy. The face of the pump cover is then machined so that it is parallel and perpendicular to the stator tube centerline. See Figure 10B-5. Without removing the pump, the facing tool is brought to the rear side of the pump cover and the gasket surface is machined. This ensures parallelism between the front and rear faces, as well as the transmission case. See Figure 10B-6.

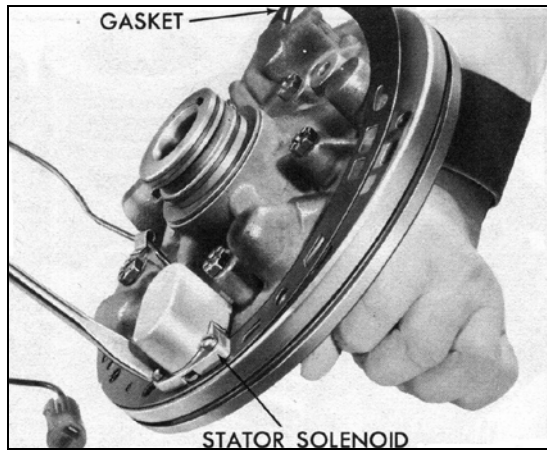
FIGURE 10C-1

Identify the type of oil pump body and oil pump cover in use. Note that all 1965 to 1967 Buick and Oldsmobile models and some 1965 to 1967 Cadillac and Rolls Royce models were produced with transmissions with the variable pitch feature. These models utilized a variable pitch specific oil pump. The pump is easily identified by the presence of a stator solenoid attached to the rear of the oil pump cover, as well as a short set of stator shaft splines. See Figures 10C-1 and 10C-2.

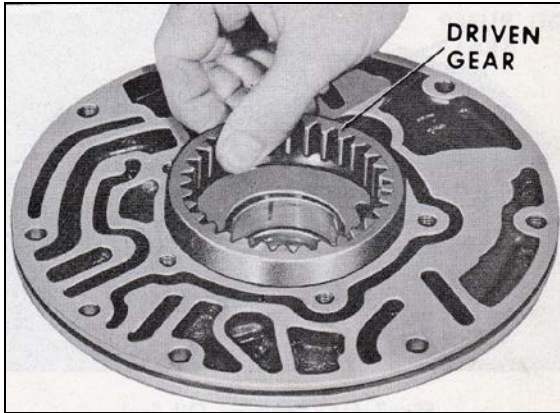
FIGURE 10C-9

Close inspection of the second design early oil pump body shows that the assembly was carried over from the GM JETAWAY for use in the GM TH400. Several oil passages remained in the casting, although not used with the TH400. The use of the TH400 specific pump cover eliminated any issues encountered with the left over passages. The JETAWAY oil pump body is shown in Figure 10C-9 and the TH400 8626121 casting in Figure 10C-10.

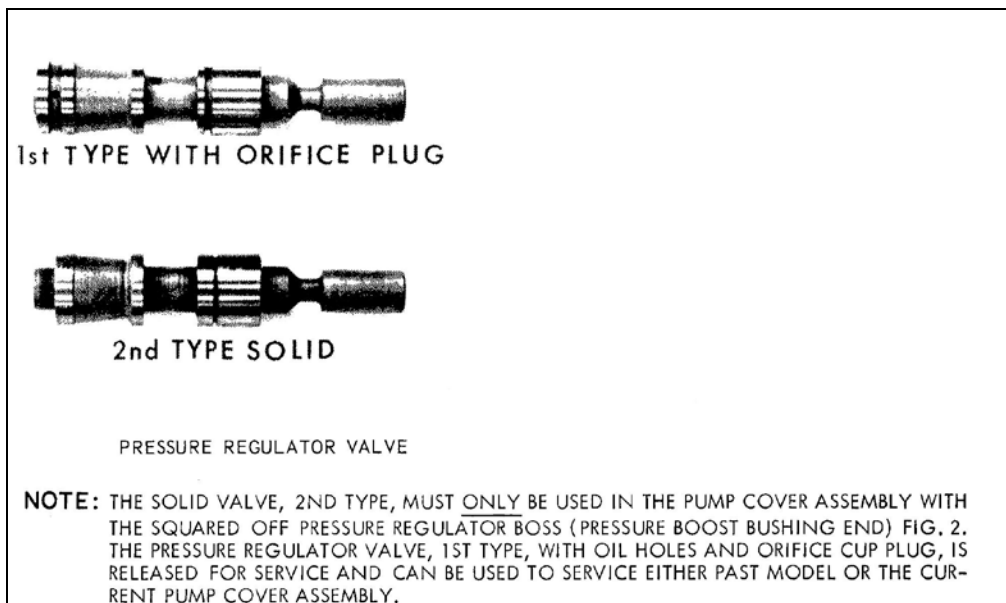
FIGURE 10C-15

This permitted the use of a solid pressure regulator valve. This was probably done as a cost saving measure, as it eliminated the drilling and plugging operations performed to the regulator valve during the manufacturing process. See Figure 10C-15.

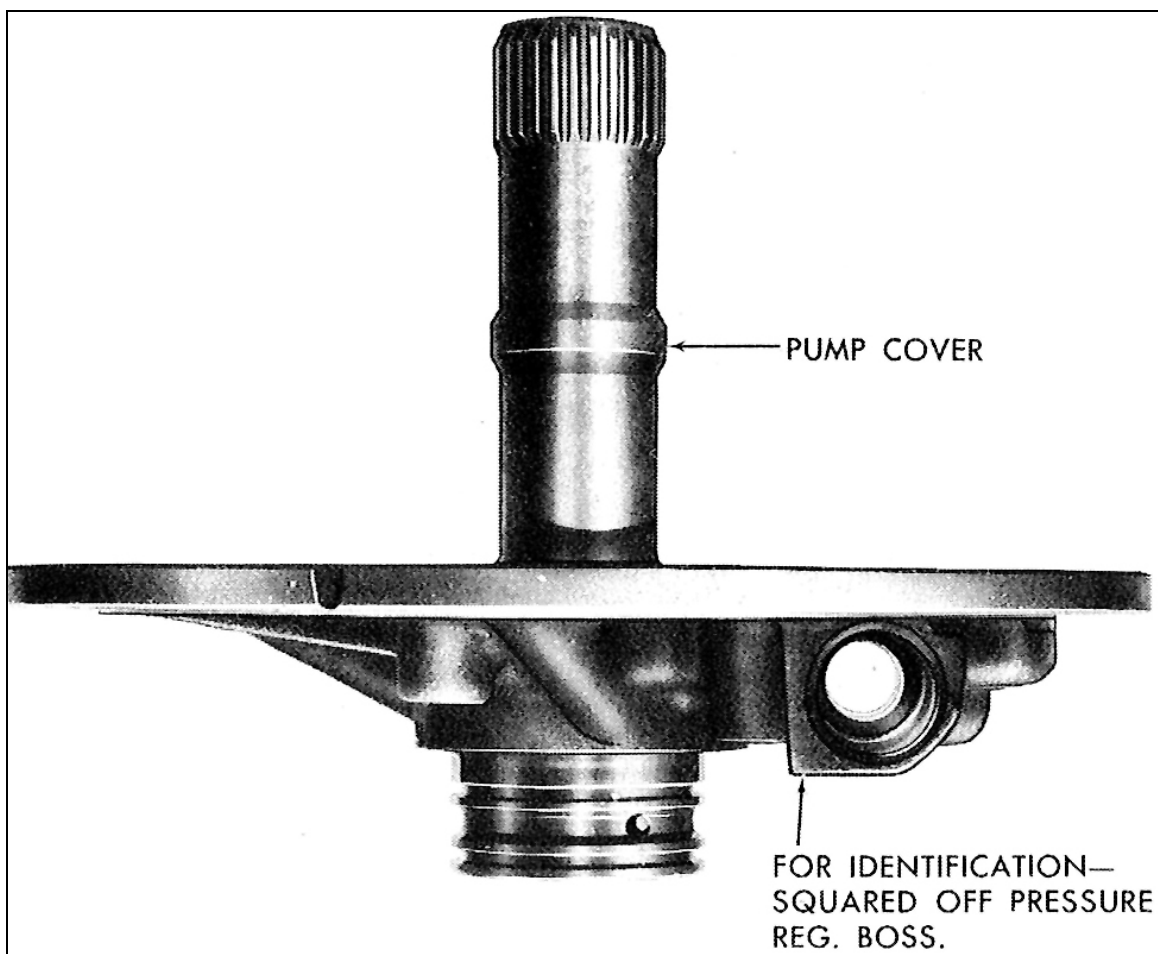
FIGURE 10C-16

For ease of identification, the 1971 to 1993 late oil pump cover, with the added pressure regulator feed hole, features a squared off pressure regulator valve boss at the boost bushing end. See Figure 10C-16. When replacing or servicing the TH400 oil pump, the absence of the squared off pressure regulator valve boss in the pump cover casting should instantly alert you to verify the type of pressure regulator valve in use.

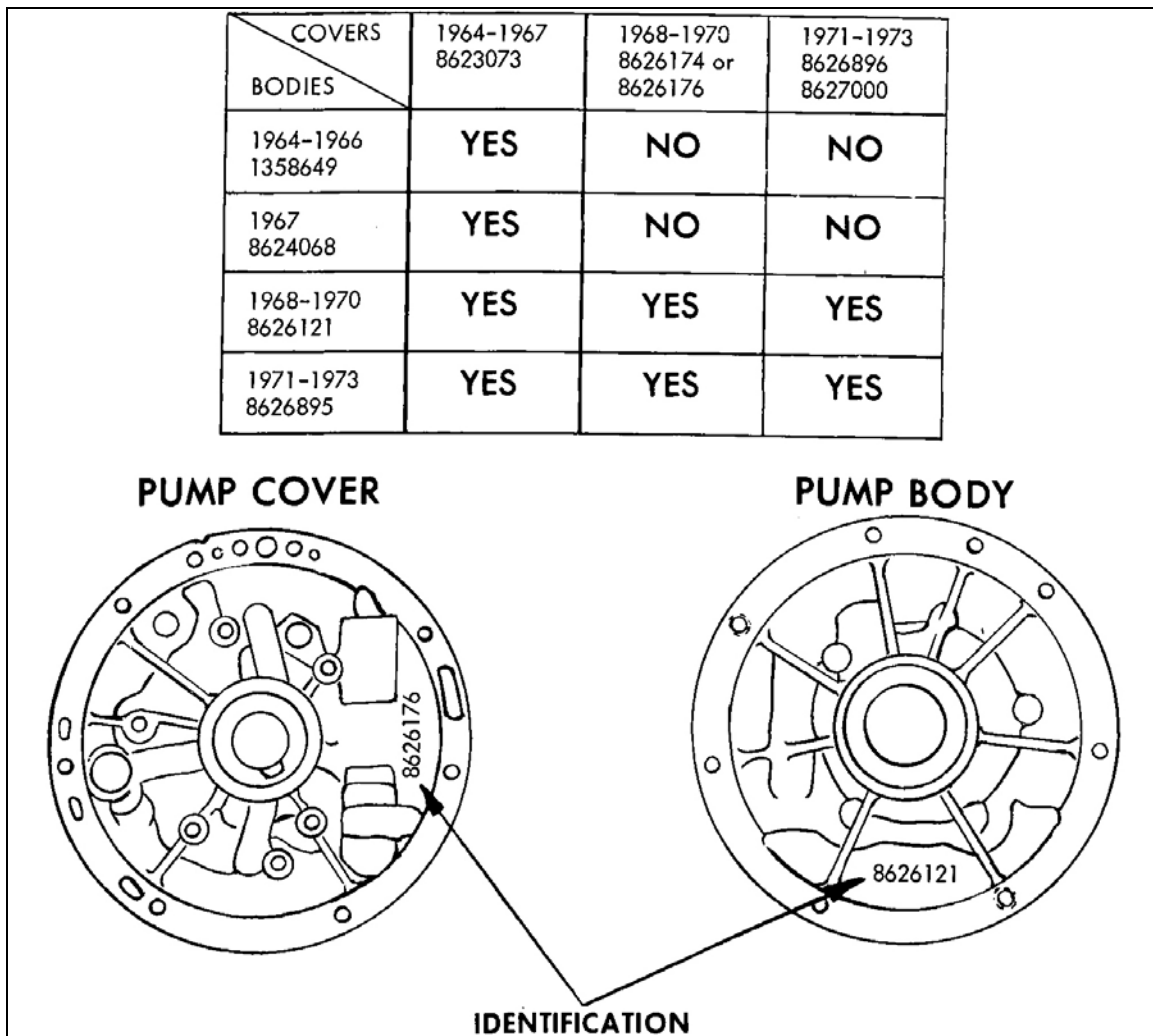
FIGURE 10C-17

Figure 10C-17 is used to quickly verify the compatibility of a specific pump body and pump cover combination when interchanging components.

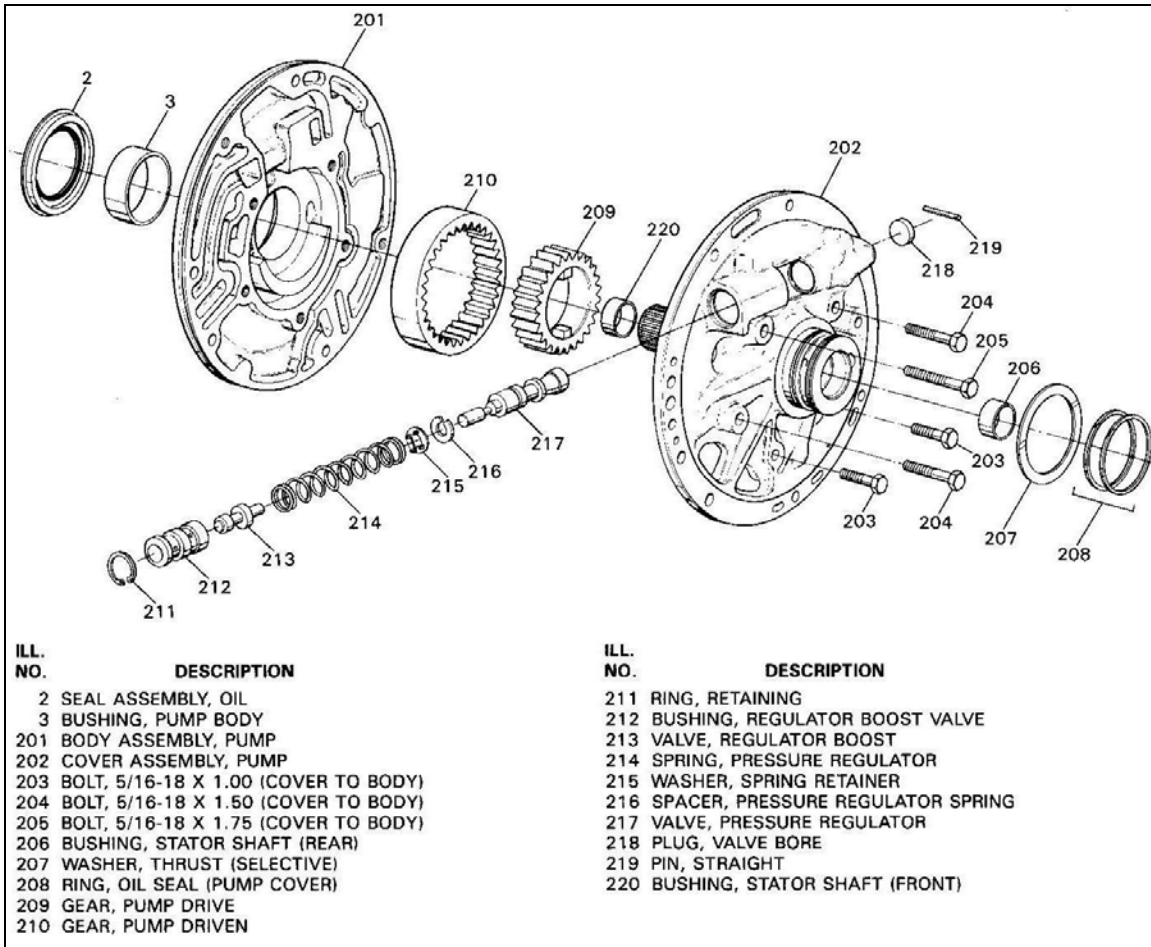
FIGURE 10E-1

Oil Pump Exploded View

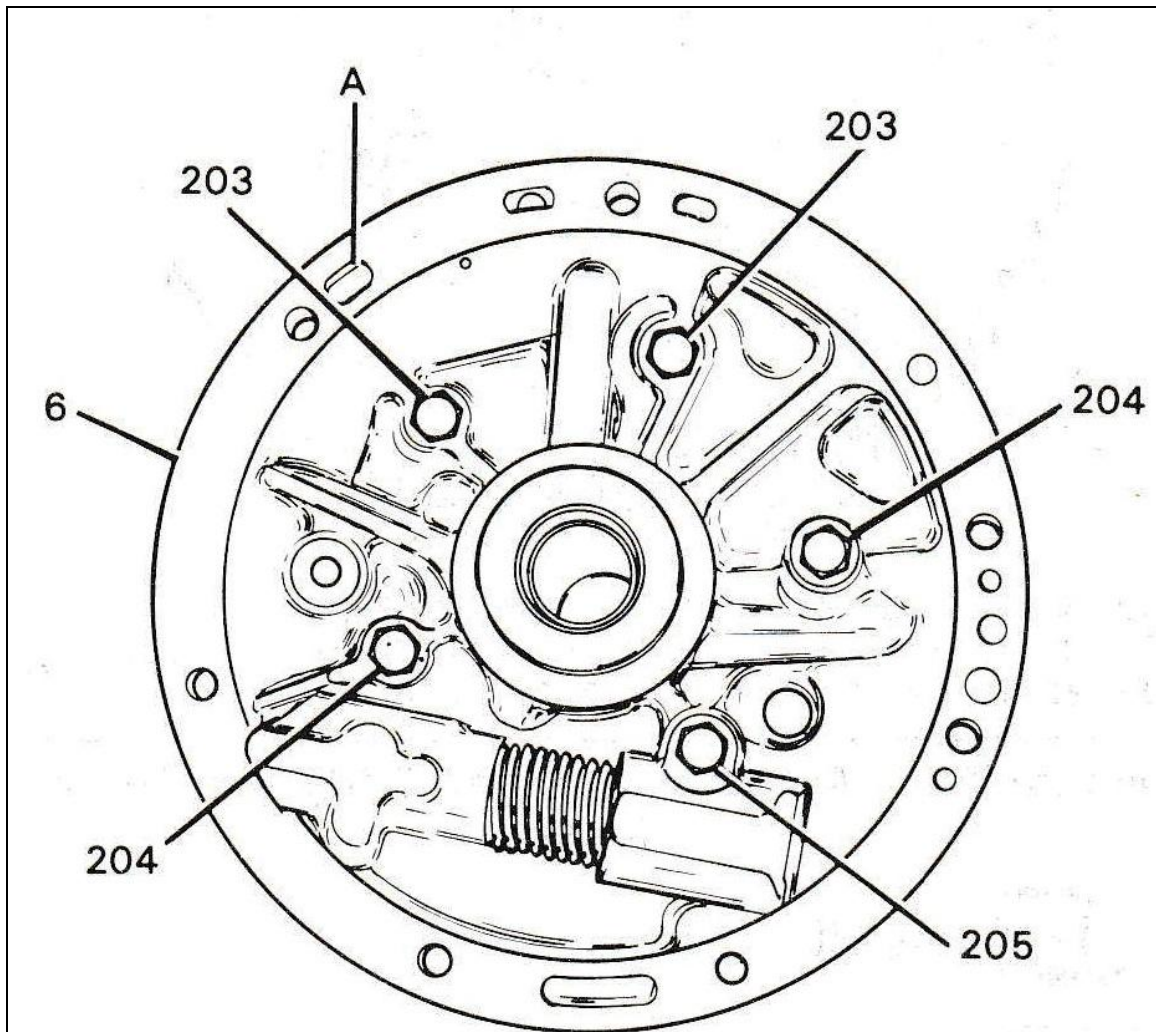
FIGURE 10E-2

Pump Cover Attaching Screws

ILL. NO.	DESCRIPTION
A	VENT HOLE
6	PUMP ASSEMBLY, COMPLETE
203	BOLT, 5/16-18 X 1.00 (COVER TO BODY)
204	BOLT, 5/16-18 X 1.50 (COVER TO BODY)
205	BOLT, 5/16-18 X 1.75 (COVER TO BODY)

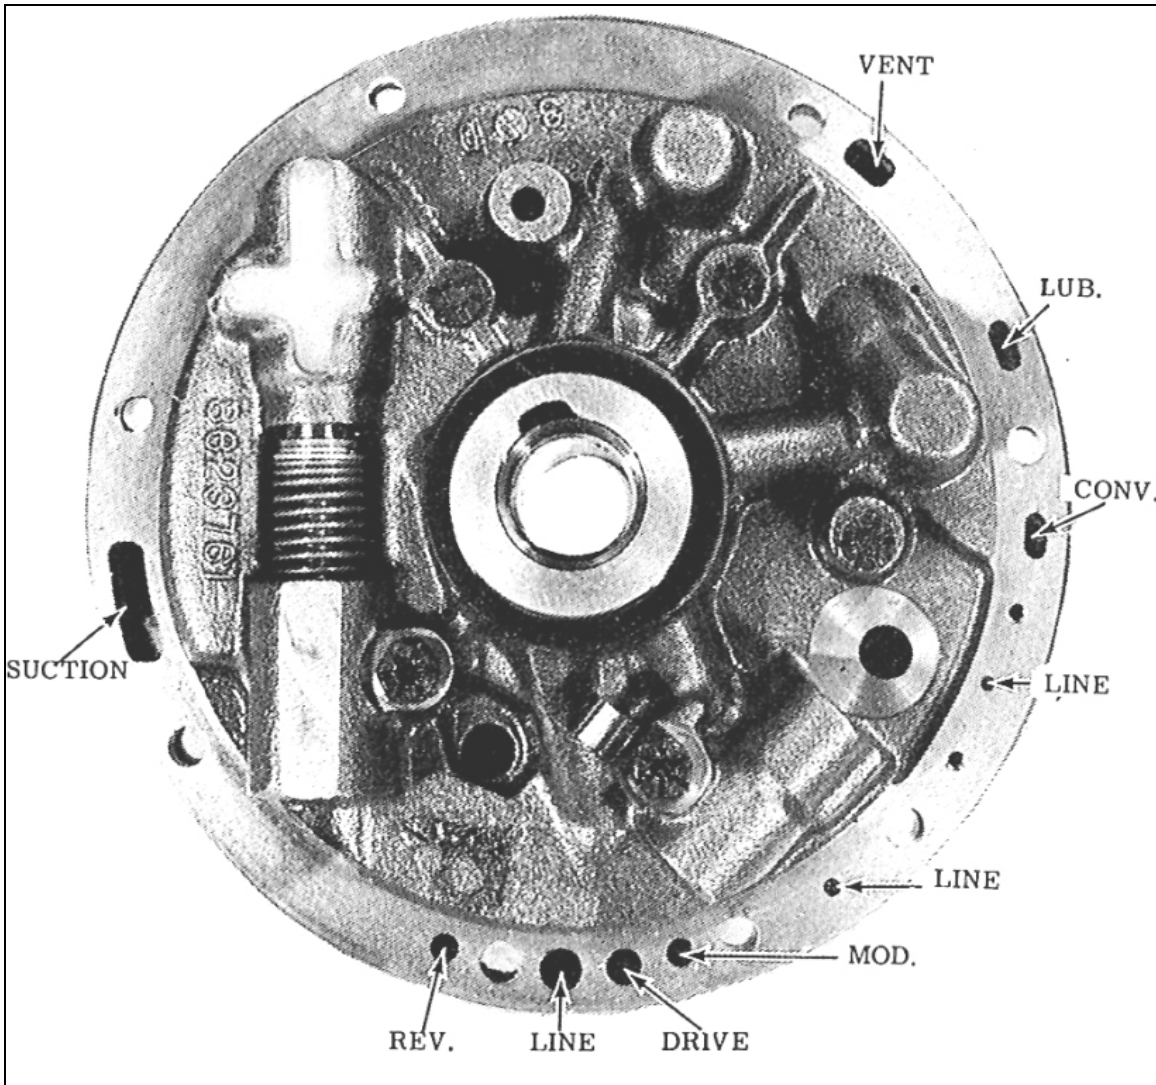
FIGURE 10E-3

Pump Cover to Cases Passages

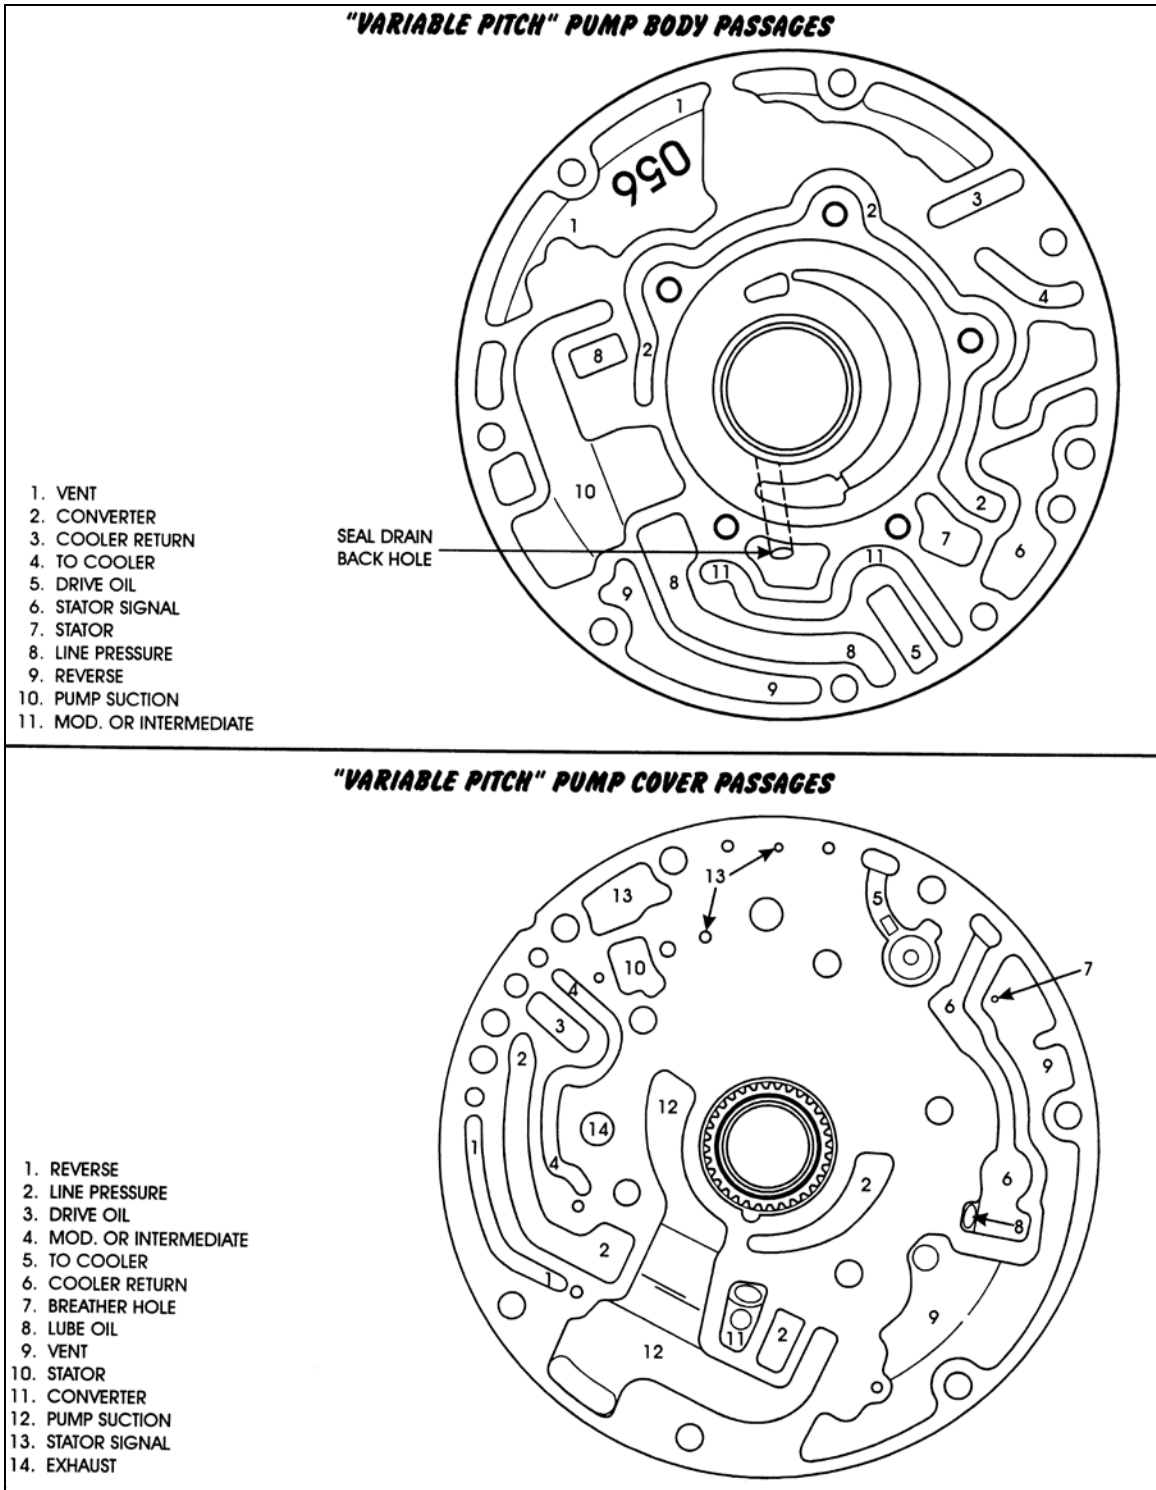
FIGURE 10E-4

Variable Pitch Pump Body and Pump Cover

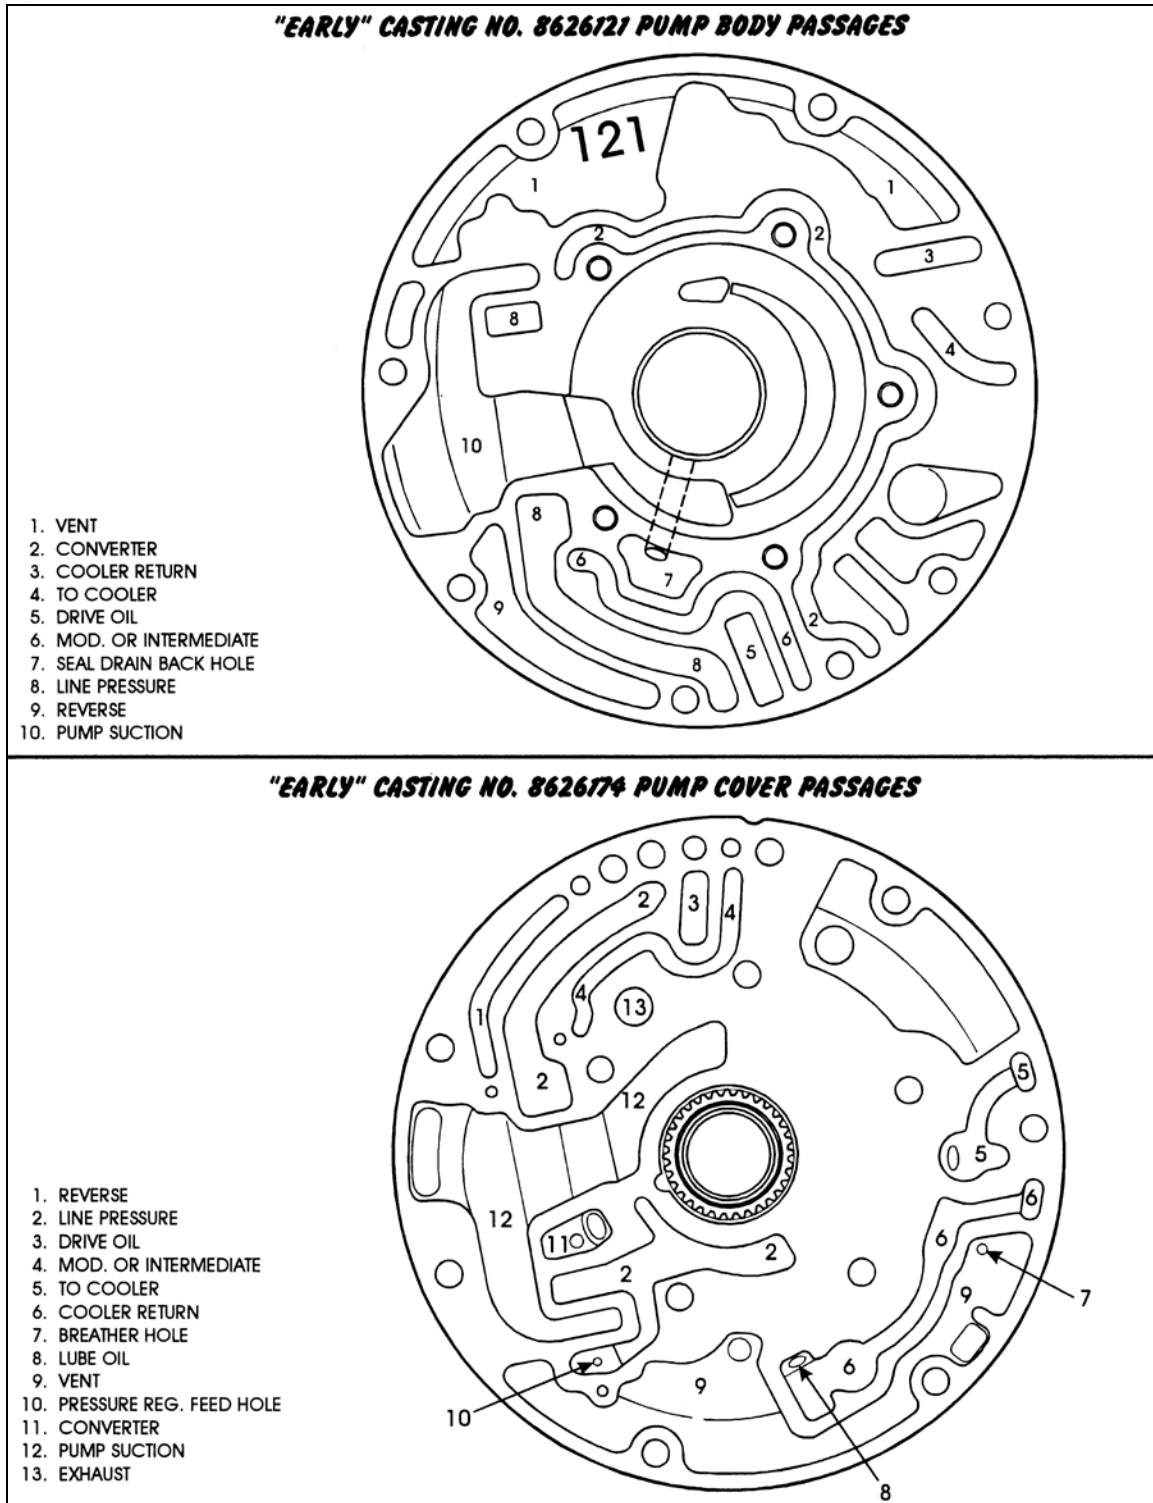
FIGURE 10E-5

Early Pump Body and Pump Cover

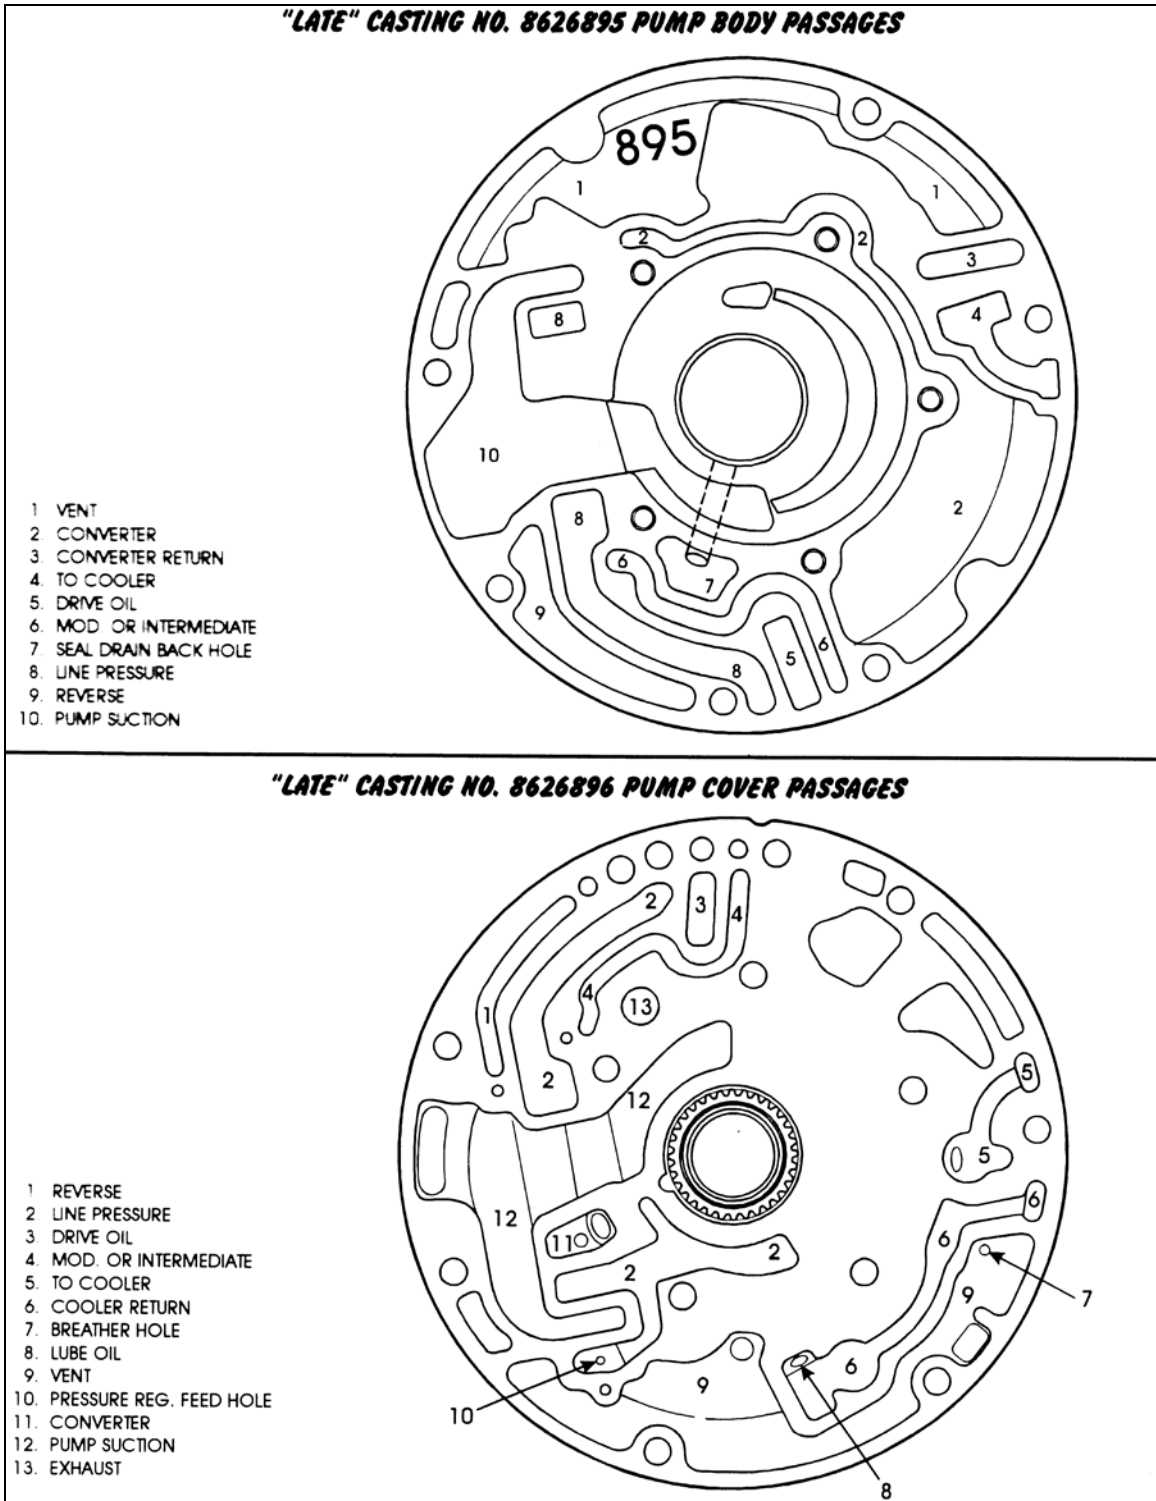
FIGURE 10E-6

Late Pump Body and Pump Cover
